# ANNUAL SURVEY REPORT ON CONDITION OF SOUTHERN CONNECTOR TOLL ROAD

## Interstate 185 - Toll

Greenville County, South Carolina

May 3, 2024

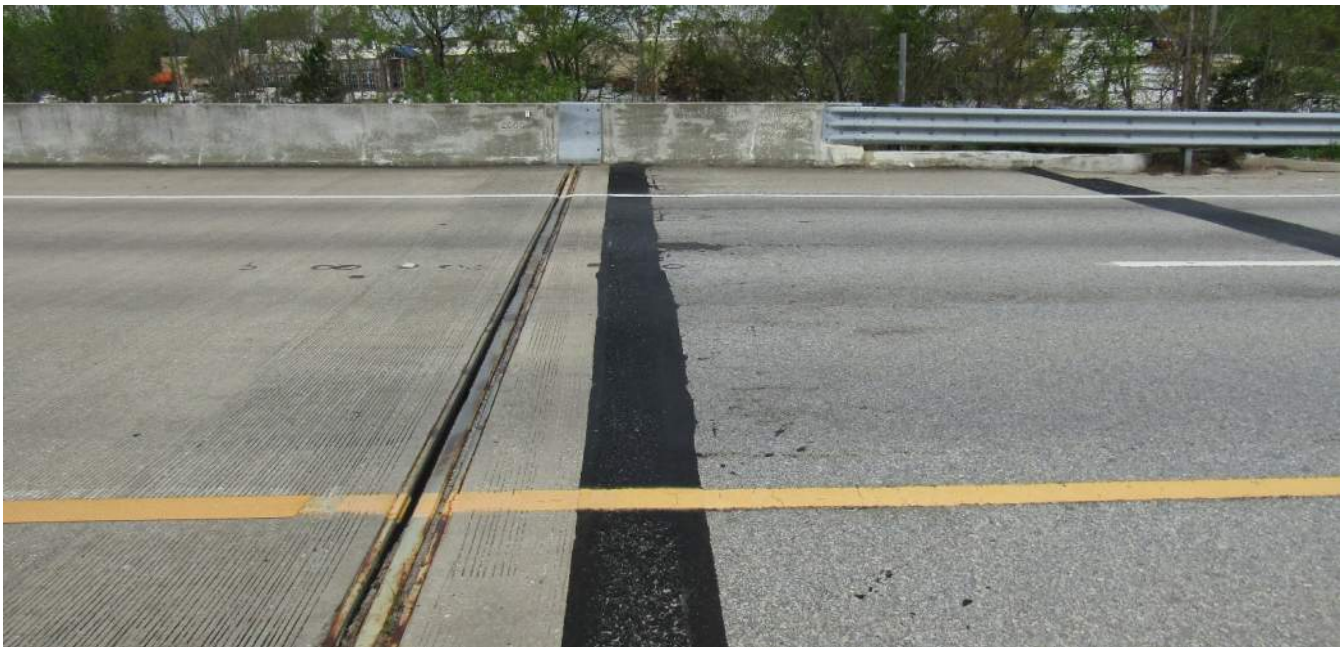
Typical asphalt joint repair

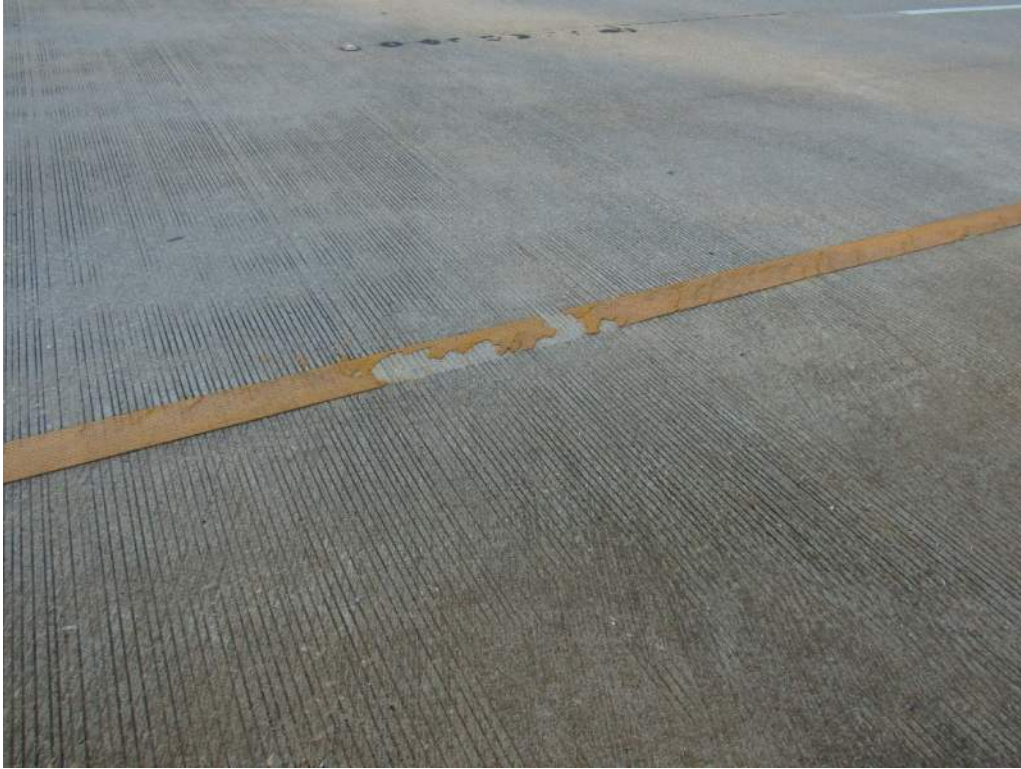
(Bridge 185-306)

Typical pavement marking delamination on bridge

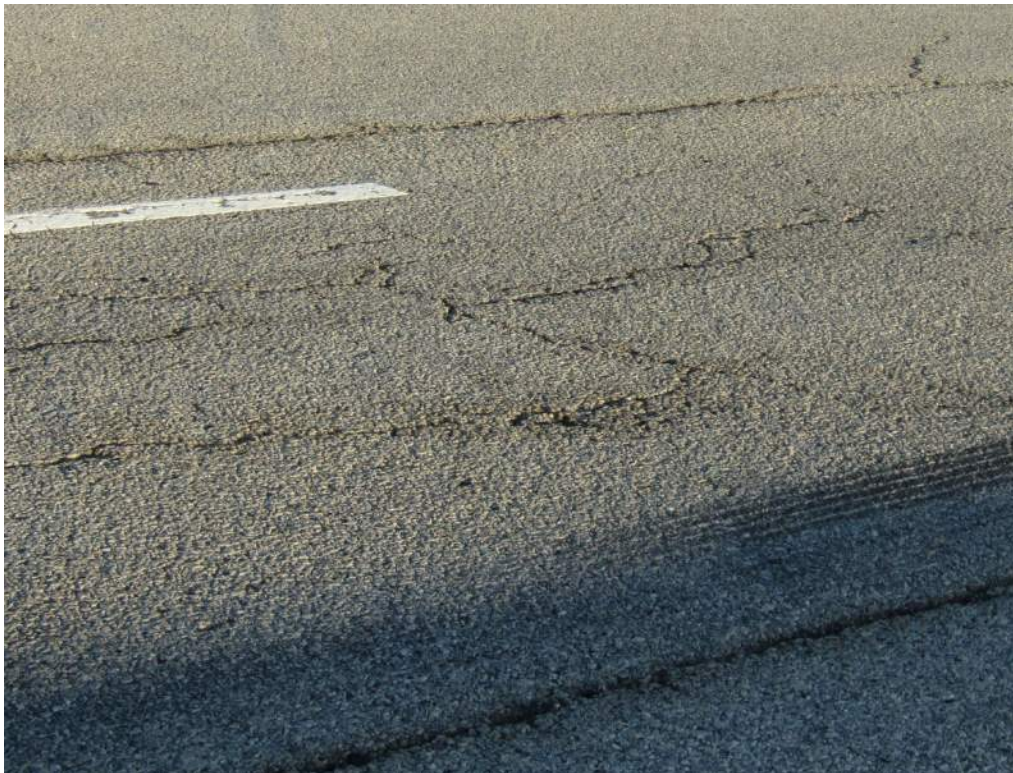
(Bridge approach 185-117)

Typical block cracking on bridge approach roadway

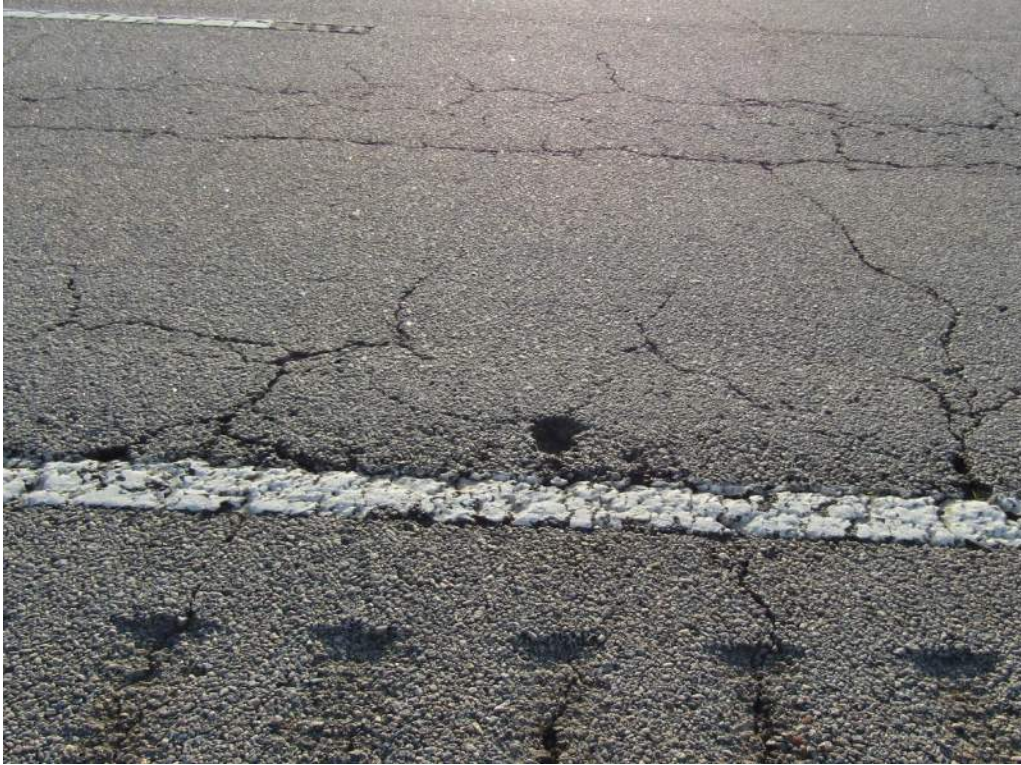
Typical block cracking on bridge approach roadway (Bridge approach 185-315)

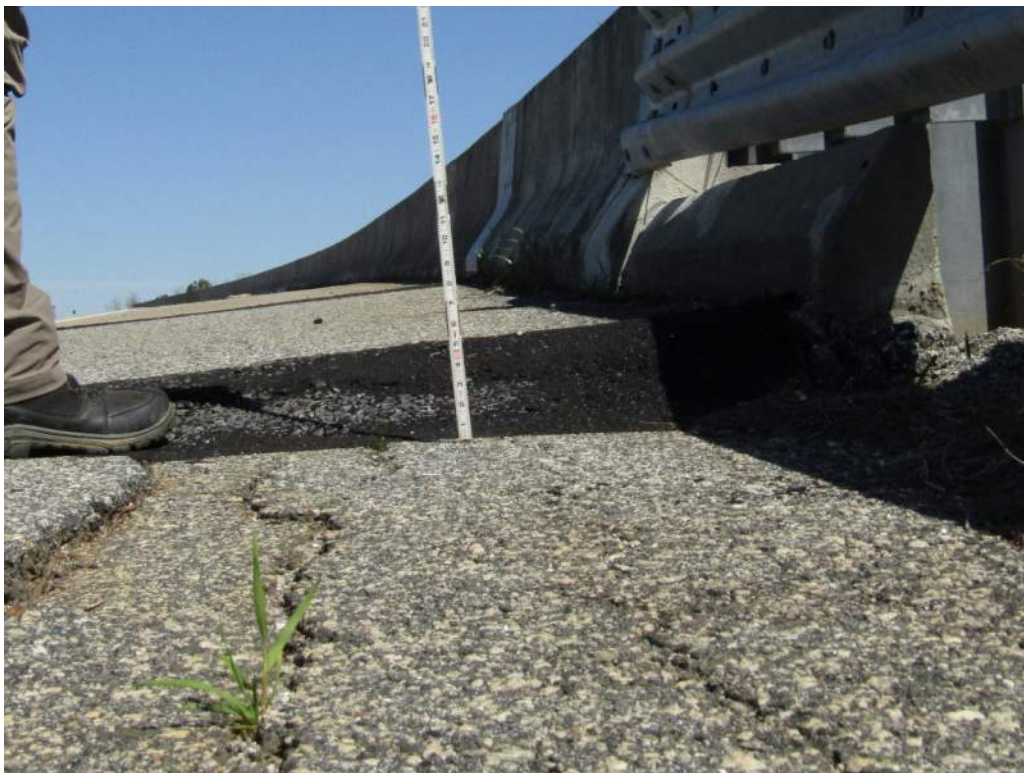
5" elevation change on bridge approach shoulder (Bridge approach 185-002)

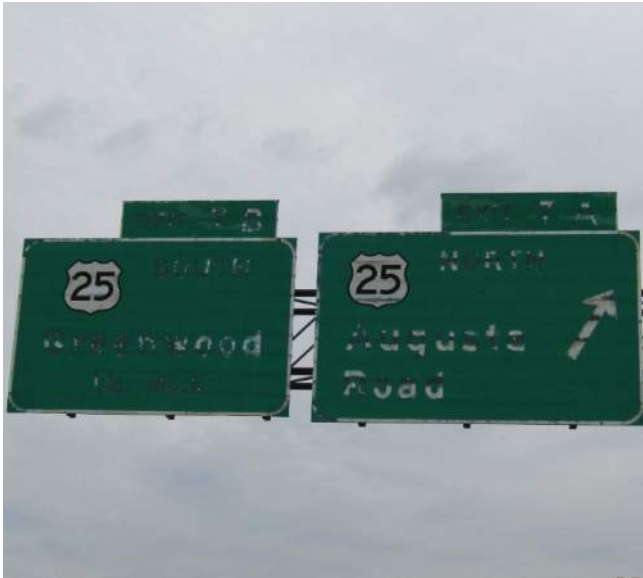
Illegible signs from March 2022

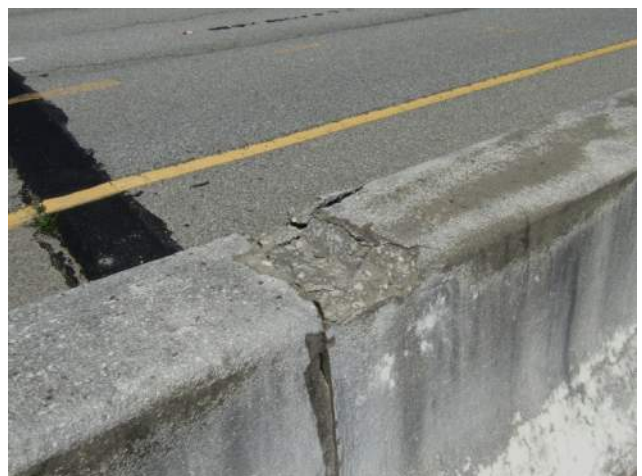
Severe block cracking and potholes were noted along the asphalt just before the approach slabs at each end of the bridge. See photo #5. There are multiple spalls in the median rail at both ends of the bridge. See photos #6-#7. Heavy vegetation growth has been cut and is dead along the MSE wall. See photo #8. At the northeast corner of the bridge, there is a large hole underneath the drainage flume and the drainage flume is partially clogged with debris. See photo #9. Cracks are beginning to form at the bridge joints with vegetation growing in the shoulders. See photo #10. There are multiple guardrail post blocks that are damaged or completely missing at the southwest approach. See photo #11. The delineator at the southwest corner has lost its retroreflective quality.

#6 185-001: Spalls in median rail

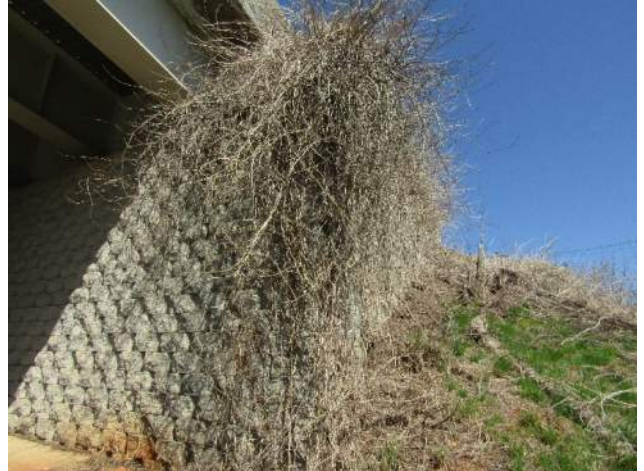
#8 185-001: Dead vegetation on MSE

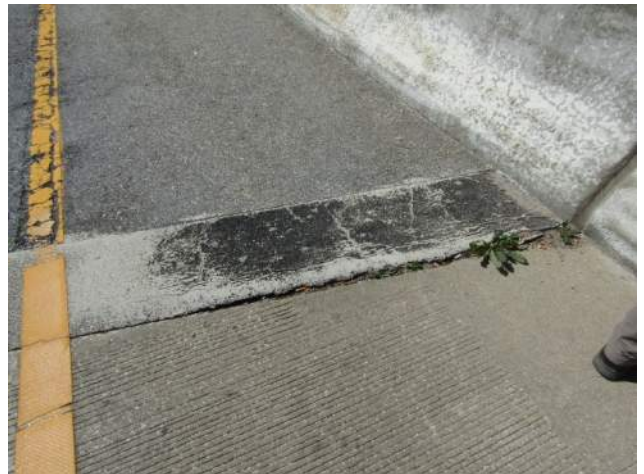
#10 185-001: Joints cracking with vegetation growth

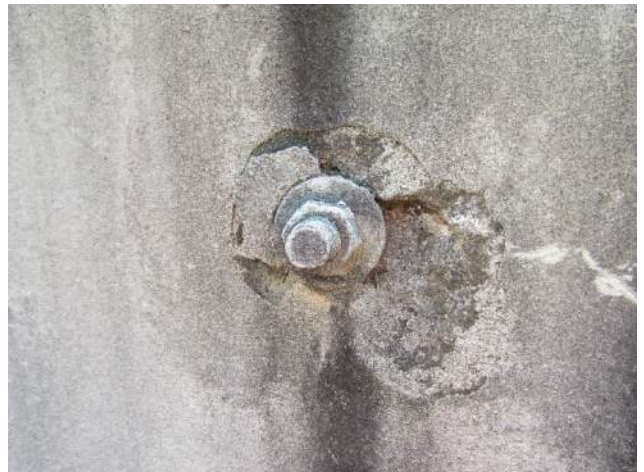
The NB bridge approach end has several defects: clogged drainage flume, loose guardrail anchorage bolt, and undermining of the approach slab. See photos #12-#14. The expansion joints at both ends of the bridge have significant debris buildup throughout the entire length of the joint and tears are beginning to develop. See photo #15. The NB bridge trailing slope protection was previously repaired for the entire length and is still in good condition. Spall repair on the north side of the last interior bent column on the NB bridge is beginning to delaminate. The NB bridge trailing end has 4 inch shoulder settlement and cracking adjacent to the catch basin. See photos #16-#17. At the top of the northwest slope protection corner, there is large cracking with settlement occurring. See photo #18.

#12 185-002: Loose anchor bolt nut

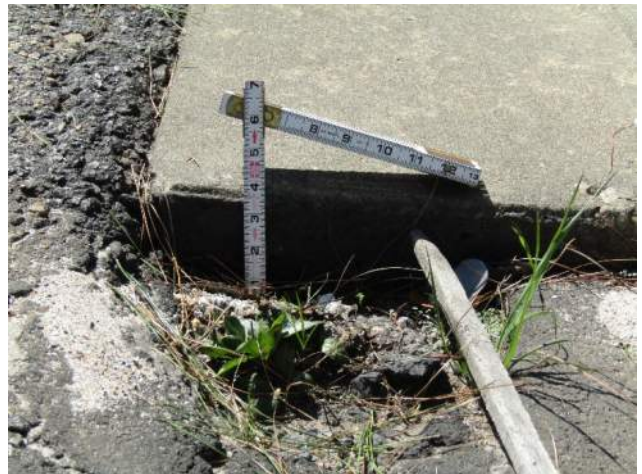
#16 185-002: Shoulder settlement and cracking

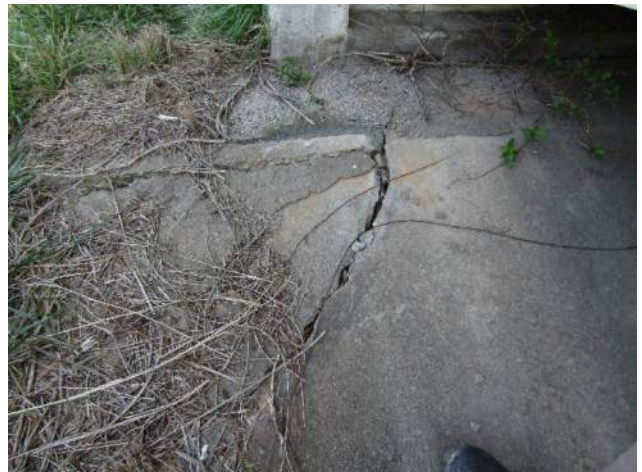
#18 185-002: Slope protection cracking and settlement

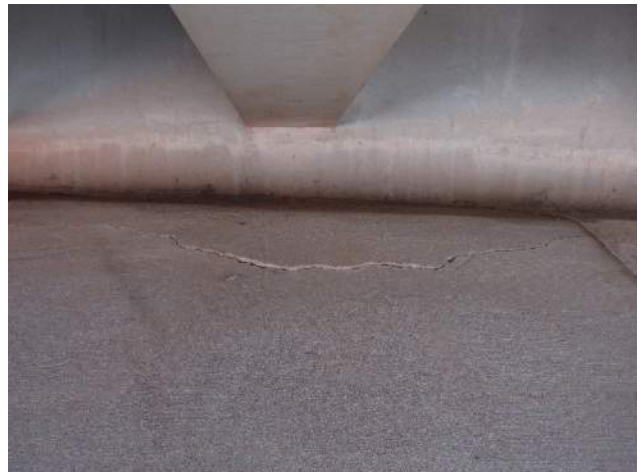
There are full depth cracks at the end of the approach slabs in the shoulders at both ends of the bridge. See photos #26-#27. The slope protection along both berms has been repaired; however, there are small cracks already forming at the top of the berms and at the bottom. See photo #28. At the top of the slope protection, there are multiple areas of undermining due to animal dwellings. See photo #29. At the northwest corner, the flume has 6 inch settlement. See photo #30.

#28 S-144-001: Cracking in slope protection

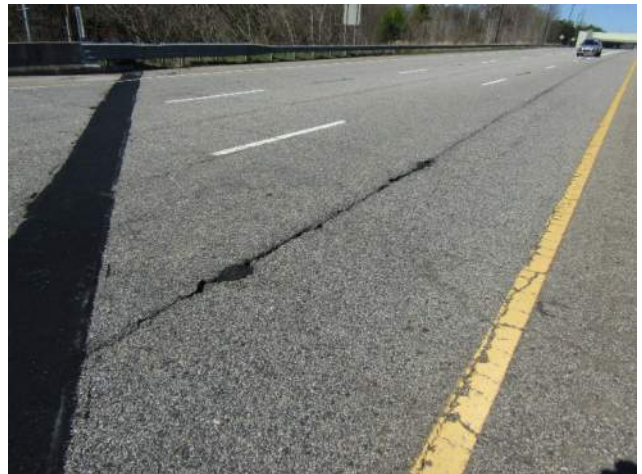
Bridge 185-103 has block and longitudinal cracking with potholes occurring near both approach slabs. See photos #34-#35. Up to 2 inch settlement is occurring at the bottom of the concrete slope protection with heavy vegetation growth. See photo #36. Bridge 185-303 has cracking up to 1 inch wide on both approach slab joints. See photo

#34 185-103: Moderate block and longitudinal cracking

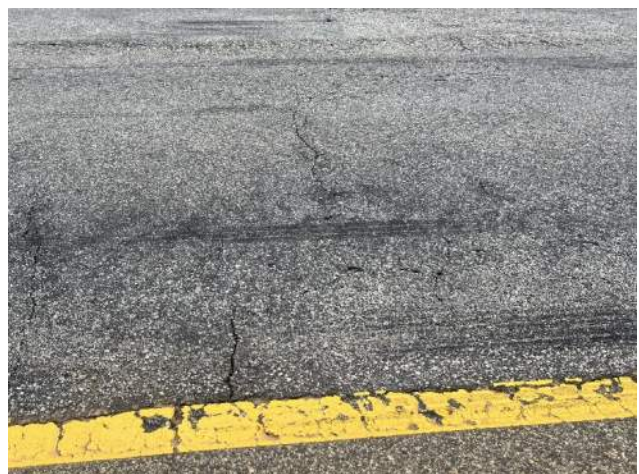
Moderate block cracking with longitudinal cracking in both approach roadways. See photo #46. The far approach slab joint has a 2 inch bump in the roadway and cracking in the shoulder. See photo #47. Downstream from the bridge, there is erosion of the streambanks with a tree that has fallen into the Reedy River. See photo #48.

#46 185-304: Approach roadway block cracking

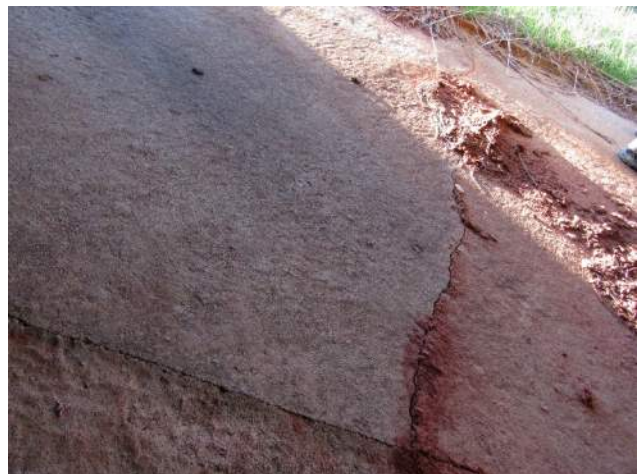
#64 185-106: Cracking and settlement in concrete slope

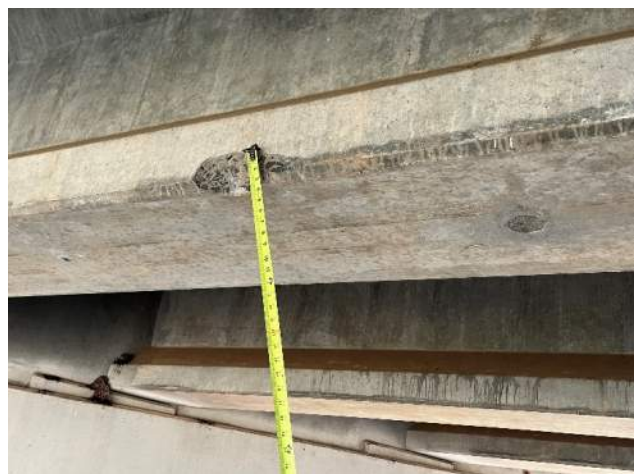
Bridge 185-106 has multiple dislodged rail post blocks next to the approach terminal. See photo #62. There are multiple longitudinal cracks in the approach roadway that extend onto the approach slab. See photo #63. Both structures have cracking and settlement of the concrete berm and heavy vegetation throughout the concrete slope protection. See photos #64- #65. Bridge 185-106 has two girders with minor spalls in the bottom flange. See

#66 185-106: Minor spall in bottom flange

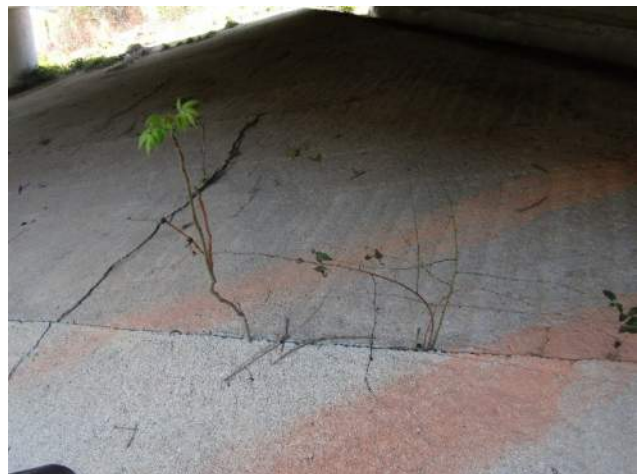
Both bridges have missing and dislodged guardrail post blocks at both ends of the bridge. See photos #69-#70. Bridge 185-107 has impact damage at the leading end. See photo #71. Bridge 185-307 has significant cracking and spalls in the approach slab joint shoulder with vegetation growth. See photos #72-#73. There are multiple longitudinal cracks with potholes in the approach roadways that extend onto the approach slab. See photo #74. Both bridges have large cracks with up to 1 inch settlement occurring along the concrete slope protection with heavy vegetation growth. See photos #75-#76.

#76 185-307: Cracking and vegetation in slope protection

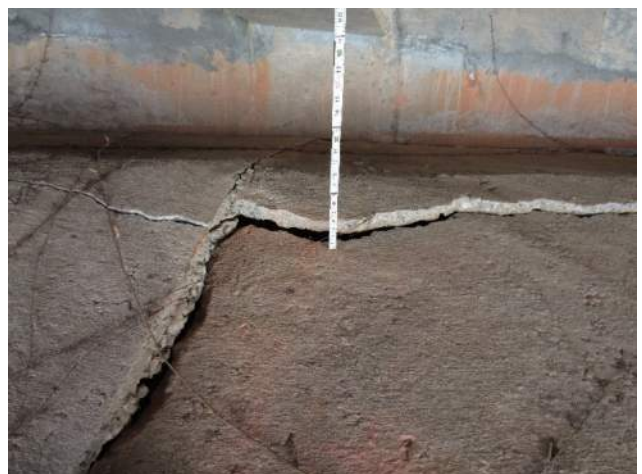
Moderate to severe block cracking occurring at both approaches with multiple potholes. See photos #77. Bridge 185-308 has cracking in the approach slab joint at the far end. Cracking and up to 3 inch settlement at top of berm of both bridges. See photos #78-#79. Bridge 185-308 has cracking occurring along the concrete berm with heavy vegetation at both ends.

#78 185-108: Cracking and settlement in top berm

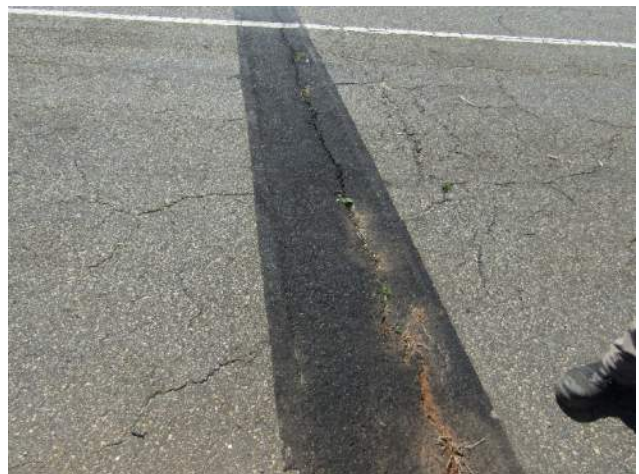
#106 185-112: Severe block cracking

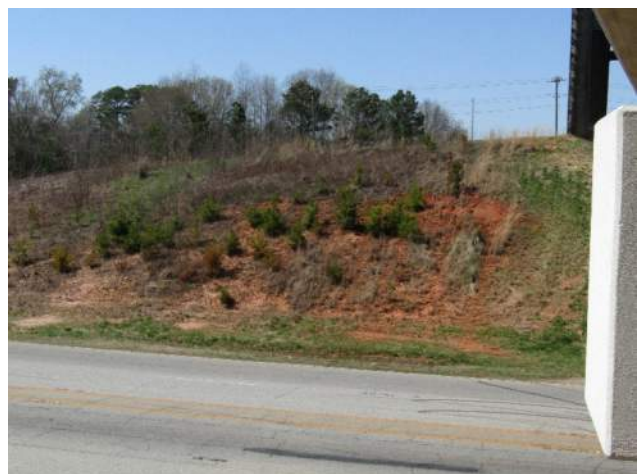
#108 185-312: Side slope erosion

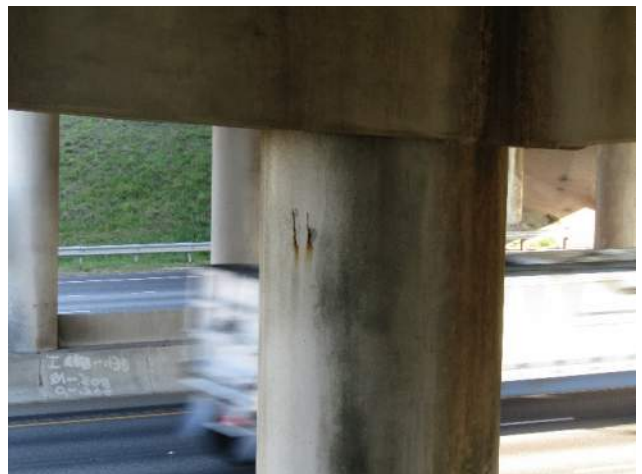
#136 185-317: Column spall with exposed rebar

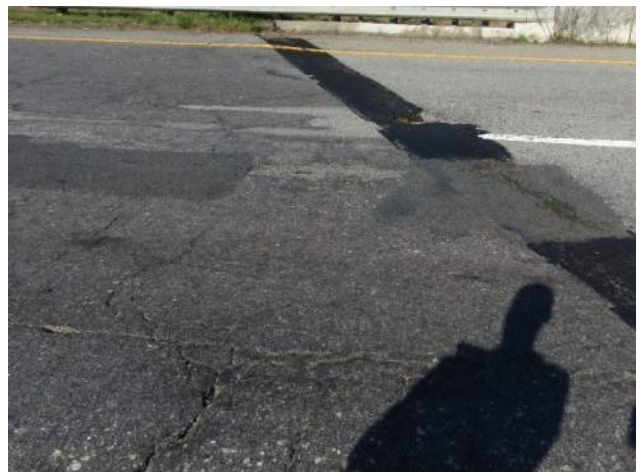
#138 185-118: Severe block cracking

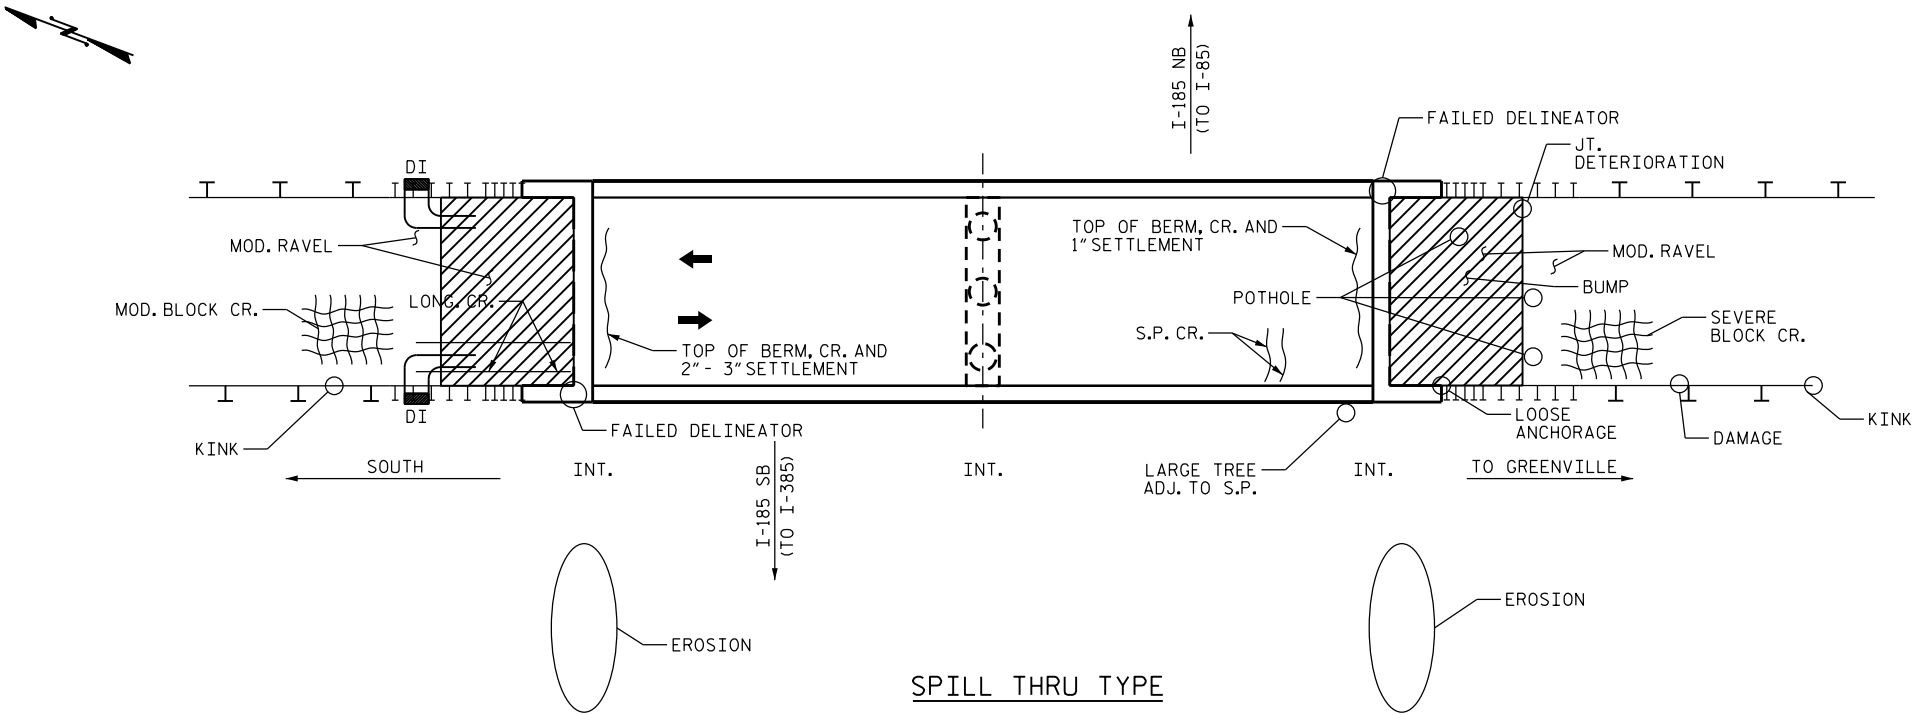
SOUTHWEST DELINEATOR TWISTED AND LOSING RETROREFLECTIVITY

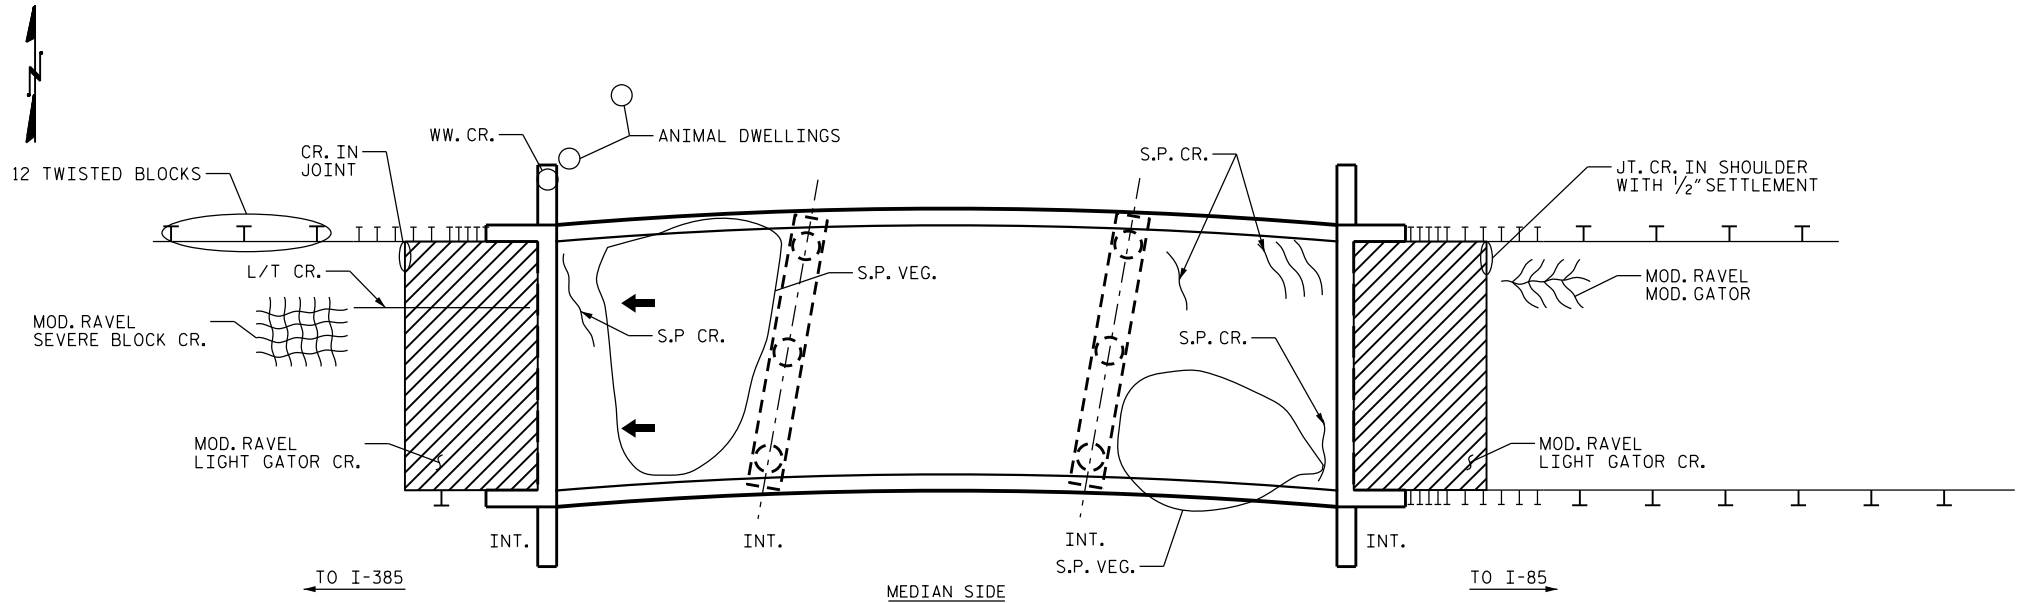
BRIDGE NO. 185-306ROAD OVER I-185 SBFACILITY UNDER REEDY FORK RD.DATE MARCH 2024

CONDITION SURVEYAPPROACHESSIGNS (2) DELINEATORS - GOODPAVEMENT MOD. RAVEL, SEVERE BLOCK.GUARDRAIL (3) CORNERSANCHORAGE GOODTERMINUS GOODDAMAGE TWISTED BLOCKSJOINT IN PAVEMENT GOODAPPROACH SLAB GOODDRAINAGE GOODPAVEMENT MARKINGS NEWSUPERSTRUCTUREBRIDGE TYPE 6 AASHTO GIRDERS/SPANDECK MEDIUM CRACKINGJOINTS INTEGRALRAILS HAIRLINE CRACKS @ 6' SPACINGBEARINGS FULL DEPTH CONCRETE DIAPHRAGMGIRDERS GOODSITEVEGETATION ON SLOPE PROTECTIONSCOUR /  
BANK EROSION N/ASLOPE EROSION  
/ UNDERMINING N/ASUBSTRUCTUREINTEGRAL END

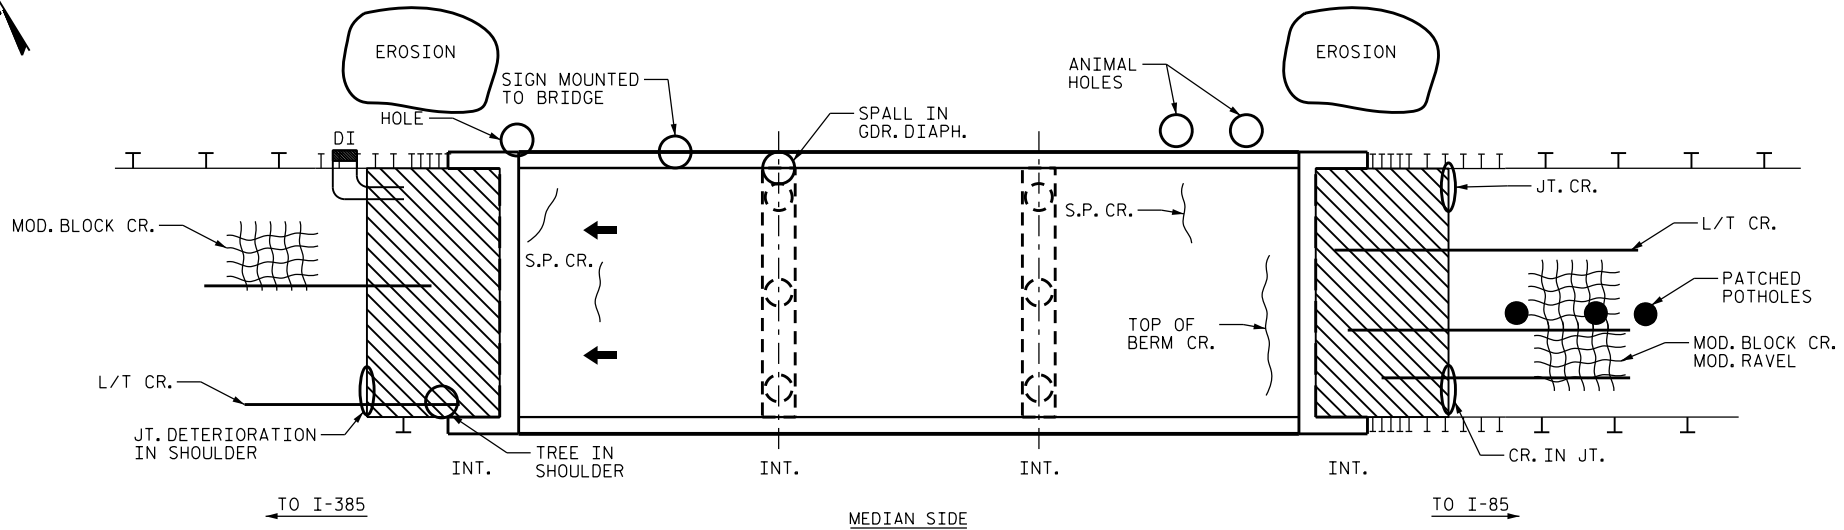
BRIDGE NO. 185-312ROAD OVER I-185 SBFACILITY UNDER SC 20DATE MARCH 2024

SPILL THRU TYPECONDITION SURVEYAPPROACHESSIGNS (2) DELINEATORS - GOODPAVEMENT MODERATE BLOCK CRACKING AND MODERATE RAVELGUARDRAIL (2) CORNERSANCHORAGE GOODTERMINUS GOODDAMAGE GOODJOINT IN PAVEMENT PATCHED 2020, SETTLEMENTAPPROACH SLAB MODERATE RAVEL AND LONGITUDINAL CRACKINGDRAINAGE GOODPAVEMENT MARKINGS NEWSUPERSTRUCTUREBRIDGE TYPE 6 AASHTO GIRDERS/SPANDECK MINOR HORIZONTAL CRACKINGJOINTS INTEGRALRAILS MEDIUM CRACKS AT 10' SPACINGBEARINGS FULL DEPTH CONCRETE DIAPHRAGMSGIRDERS MINOR GRAFFITISITEVEGETATION ALONG SLOPE PROTECTIONSCOUR /  
BANK EROSION N/ASLOPE EROSION  
/ UNDERMINING N/ASUBSTRUCTUREINTEGRAL END

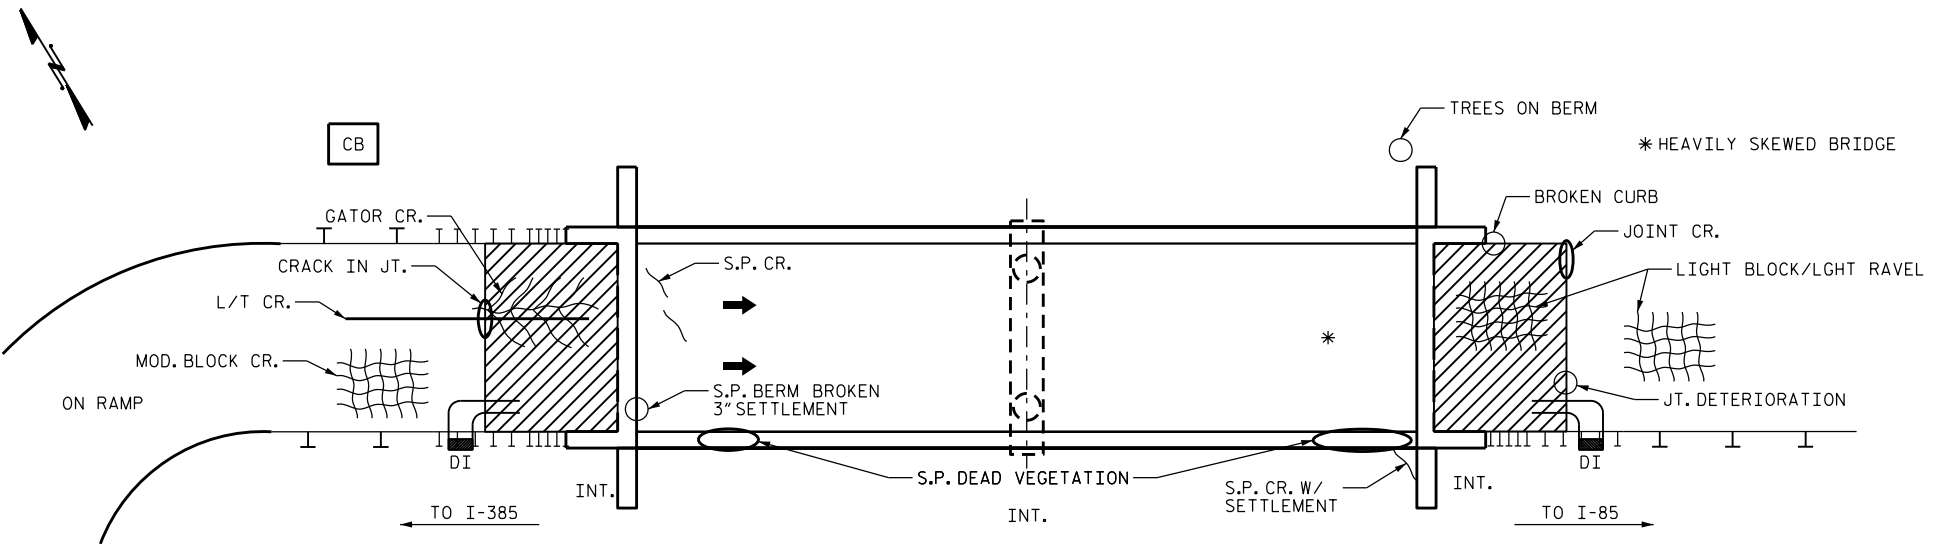
BRIDGE NO. 185-1271ROAD OVER RAMP ON I-185 (OFF SC 20)FACILITY UNDER NS & CSX RRDATE MARCH 2024

SPILL THRU TYPECONDITION SURVEYAPPROACHESSIGNS (2) DELINEATORS - GOODPAVEMENT MODERATE RAVEL, LONG. CR. AND SEVERE BLOCKGUARDRAIL GOODANCHORAGE NE GUARDRAIL ATTACHMENT MISSING (1) BOLTTERMINUS GOODDAMAGE GOODJOINT IN PAVEMENT PATCHED, CRACKS IN JOINT, SLIGHT BUMPAPPROACH SLAB MODERATE RAVEL.DRAINAGE GOODPAVEMENT MARKINGS NEWSUPERSTRUCTUREBRIDGE TYPE 4 AASHTO BULB TEES/SPANDECK DEAD VEGETATION AT ENDSJOINTS INTEGRALRAILS HORIZONTAL CRACKS AT 8' SPACINGBEARINGS FULL DEPTH CONCRETE DIAPHRAGMGIRDERS GOODSITEALONG ABUTMENT ON SLOPE PROTECTION, BERM,  
VEGETATION AND OVERHANGSSCOUR /  
BANK EROSION N/ASLOPE EROSION  
/ UNDERMINING N/ASUBSTRUCTUREINTEGRAL END

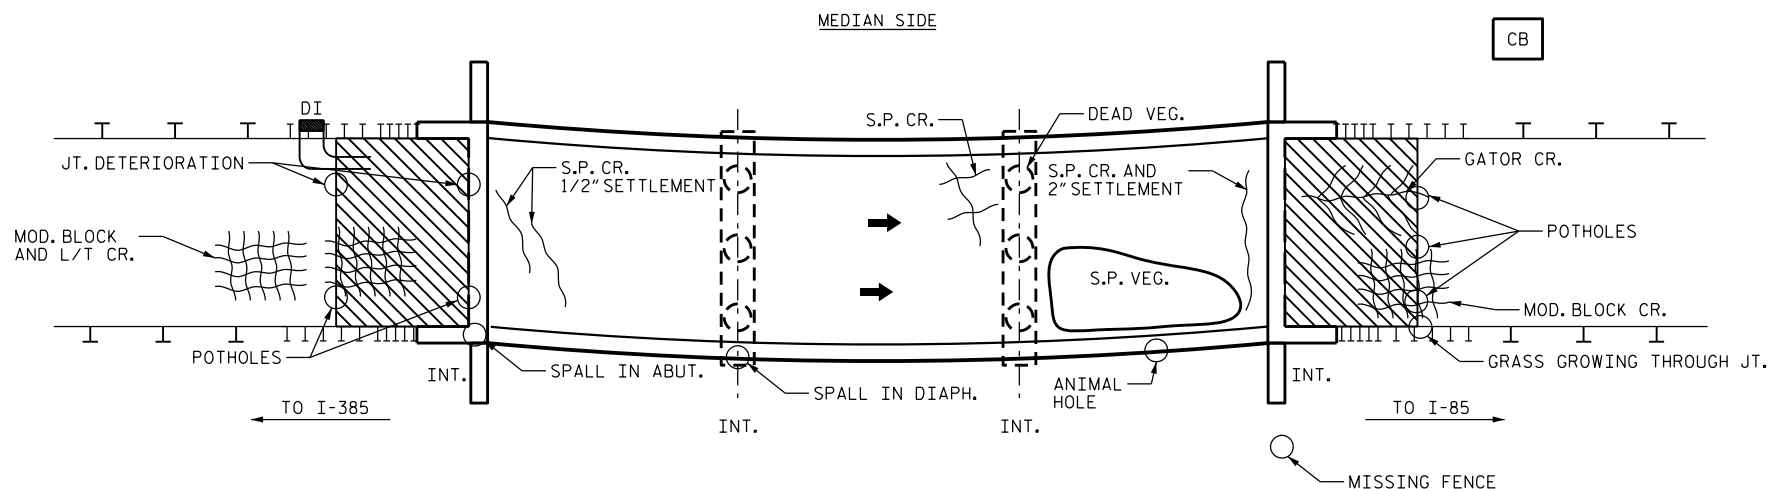
BRIDGE NO. 185-115ROAD OVER I-185 NBFACILITY UNDER STABLES RD.DATE MARCH 2024

SPILL THRU TYPECONDITION SURVEYAPPROACHESSIGNS (2) DELINEATORS - GOODPAVEMENT MODERATE RAVEL, MODERATE BLOCK AND LONGITUDINAL CRACKING

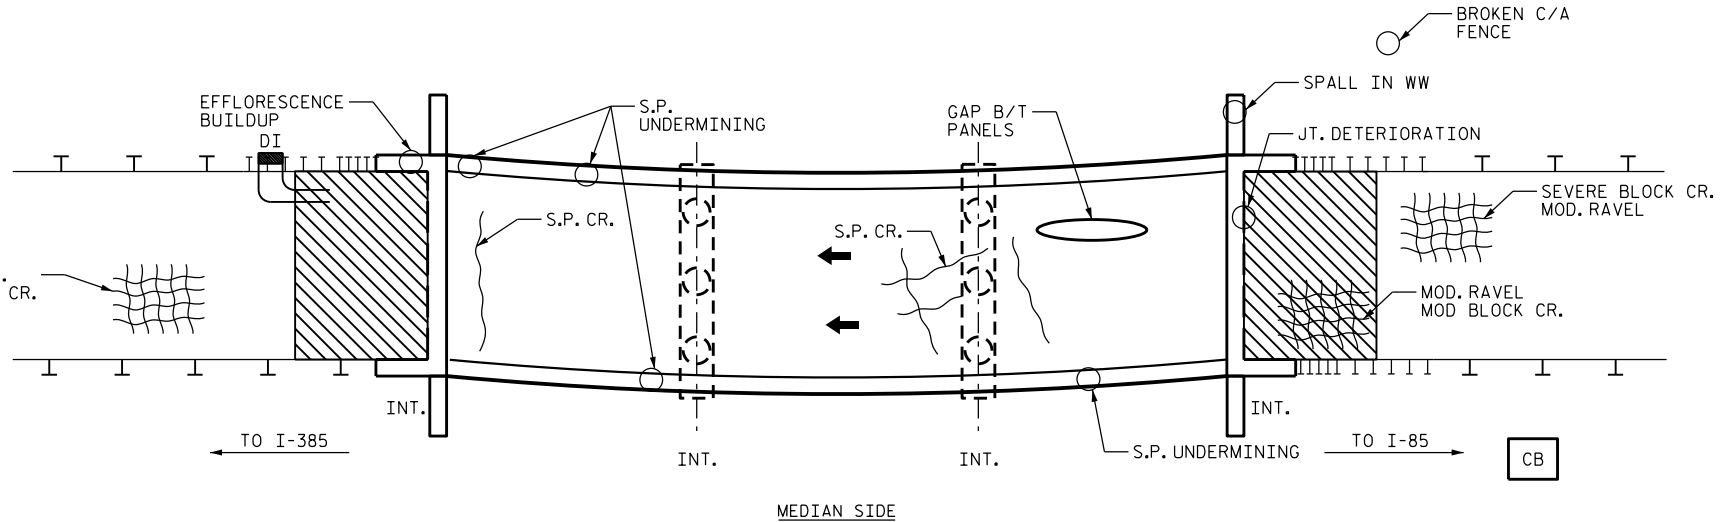
BRIDGE NO. 185-315ROAD OVER I-185 SBFACILITY UNDER STABLES RD.DATE MARCH 2024

SPILL THRU TYPECONDITION SURVEYAPPROACHESSIGNS (2) DELINEATORS - GOODPAVEMENT SEVERE RAVEL, MODERATE TO SEVERE BLOCK, LIGHT GATOR CRACKINGGUARDRAIL (3) CORNERSANCHORAGE GOODTERMINUS GOODDAMAGE GOODJOINT IN PAVEMENT PATCHED, DETERIORATED, DEPRESSIONS THROUGHOUTAPPROACH SLAB SEVERE RAVEL, MODERATE BLOCK AND LIGHT GATOR CRACKINGDRAINAGE GOODPAVEMENT MARKINGS NEWSUPERSTRUCTUREBRIDGE TYPE 5 AASHTO GIRDERS/SPANDECK WEARING WITH POOR GROOVINGJOINTS INTEGRALRAILS HEAVY EFFLORESCENCE, PEELING COATING BACKSIDE HORIZONTAL CRACKING 6'-8' SPACING,BEARINGS FULL DEPTH CONCRETE DIAPHRAGMGIRDERS GRAFFITI ON BENT 1 ENDSITEVEGETATION SIGNIFICANT ALONG SLOPE PROTECTION SIDESSCOUR /  
BANK EROSION N/ASLOPE EROSION  
/ UNDERMINING N/ASUBSTRUCTUREINTEGRAL END
