# ANNUAL SURVEY REPORT ON CONDITION OF SOUTHERN CONNECTOR TOLL ROAD

## Interstate 185 - Toll

Greenville County, South Carolina

May 3, 2024

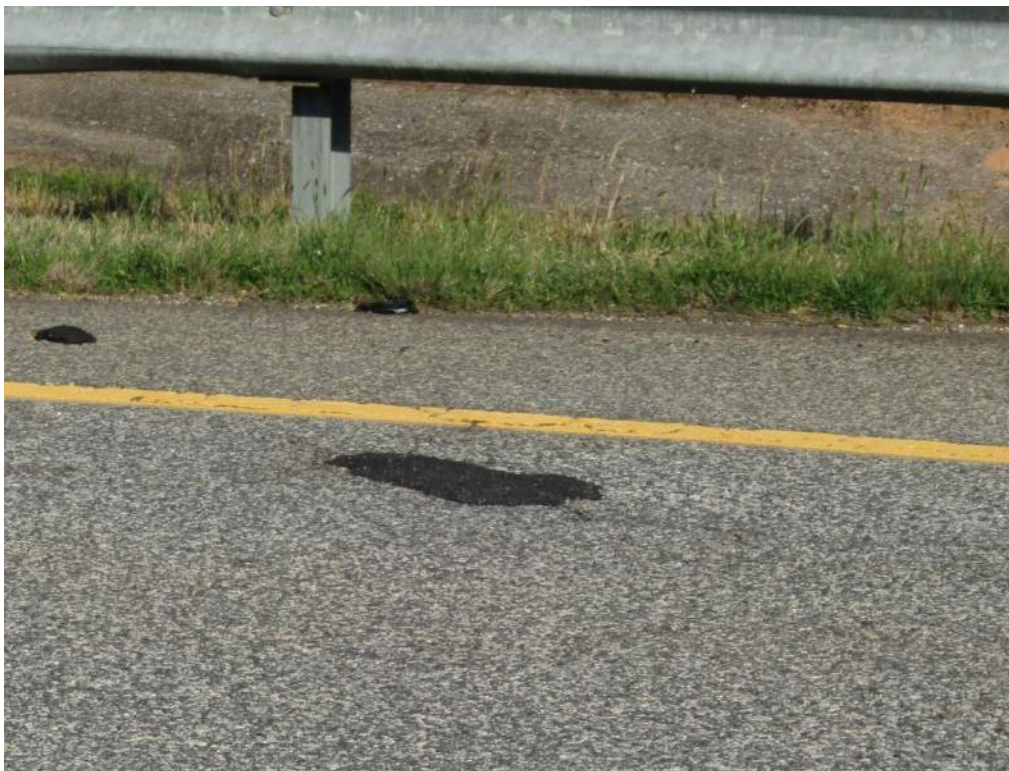
Typical patched pothole

(Bridge approach 185-305)

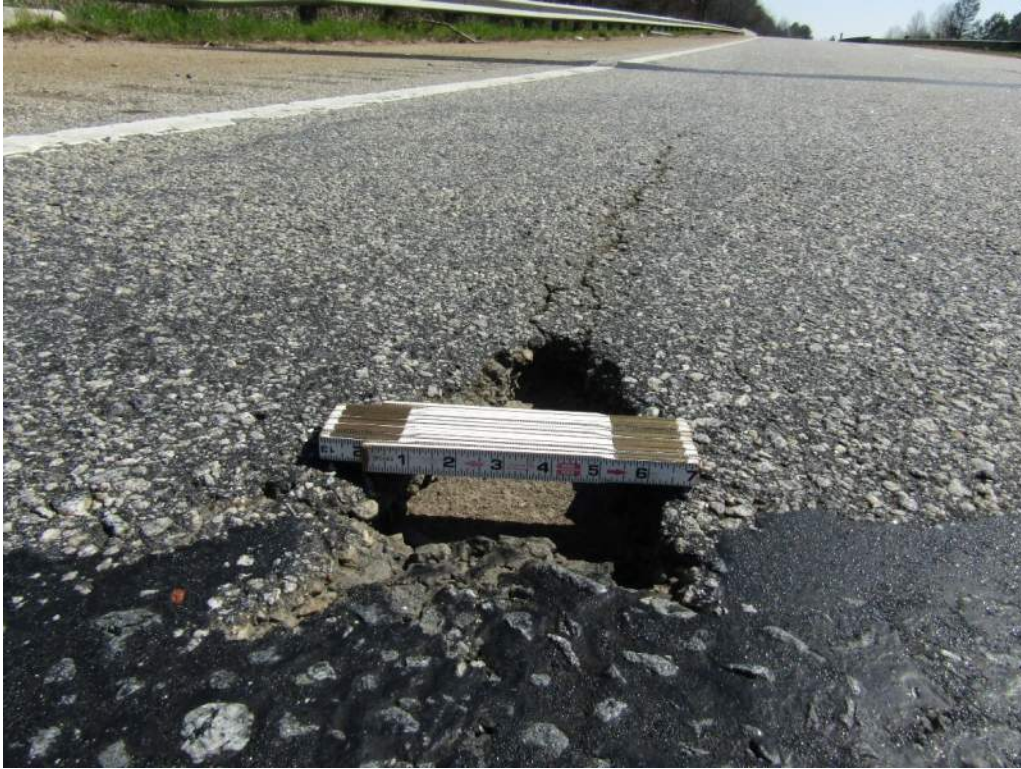
Pothole

(Bridge approach 185-109)

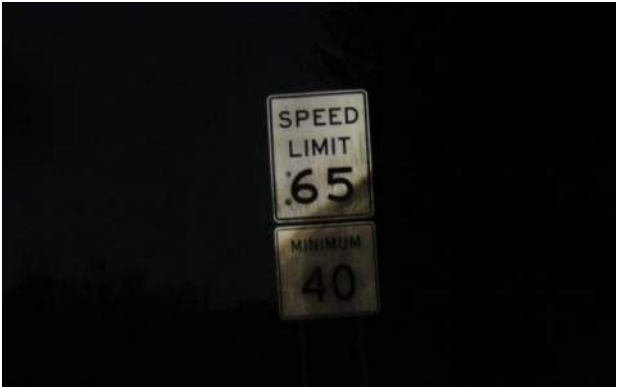
Sign Description	Location and Condition	Photo
Posted Speed Limit	I-185 NB before Exit 14, loss of retro reflectivity, similar other signs

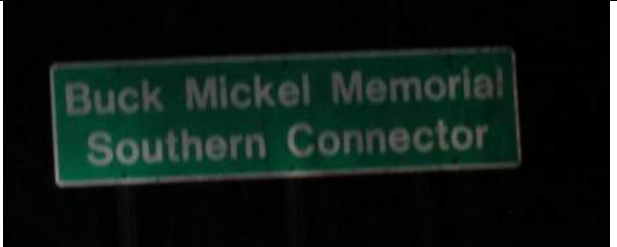
Buck Mickel Memorial Southern Connector	Loss of retro reflectivity, similar other signs

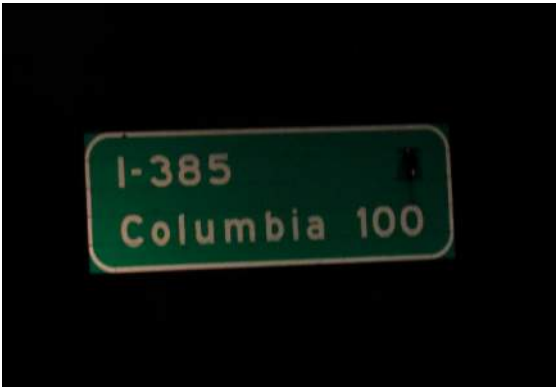
I-385 Destination	Southbound, number illegible, loss of retro reflectivity

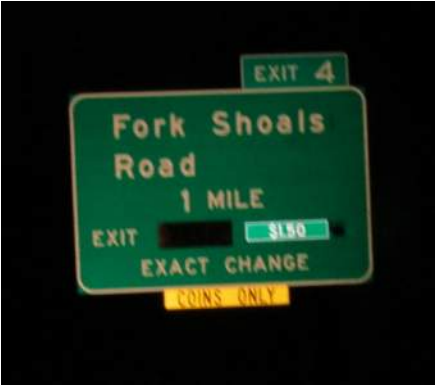
Sign Description	Location and Condition	Photo
Exit 4 Fork Shoals Road	Exit 4 SB, “Toll” not visible at night, loss of retro reflectivity

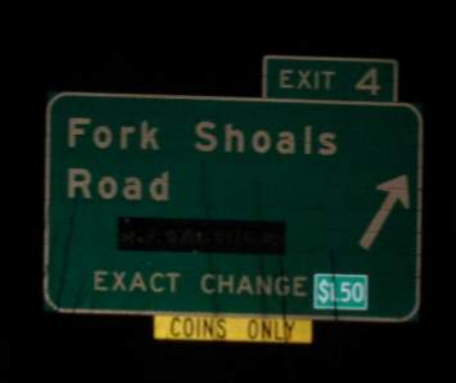
Exit 4 Fork Shoals Road	Exit 4 SB, “Pay Toll” not visible at night, loss of retro reflectivity

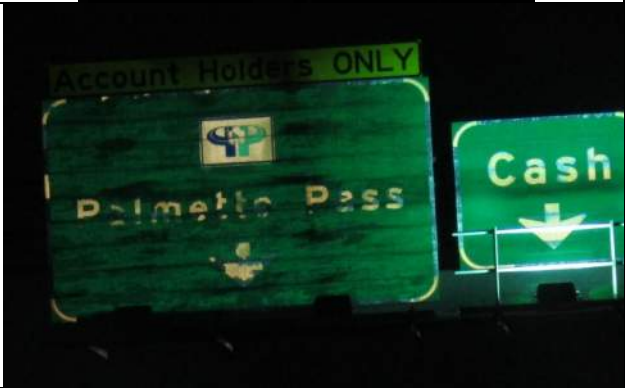
Palmetto Pass	East Plaza, “Palmetto Pass” and Arrow illegible at night, letter degradation, loss of retro reflectivity, lighting appeared out

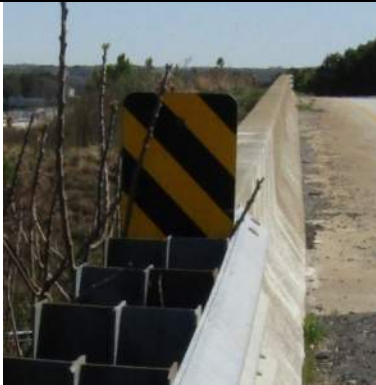
Sign Description	Location and Condition	Photo
Object marker	276-271, sign installed too low, blocked by guardrail

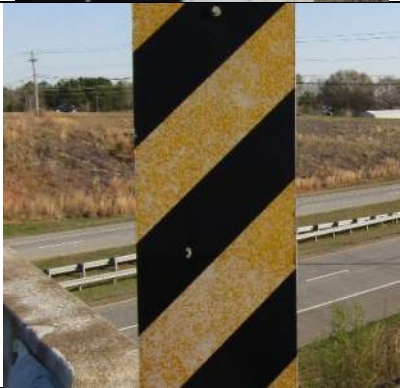
Object marker	S146-001, peeling, color cracking and degraded, typically for older

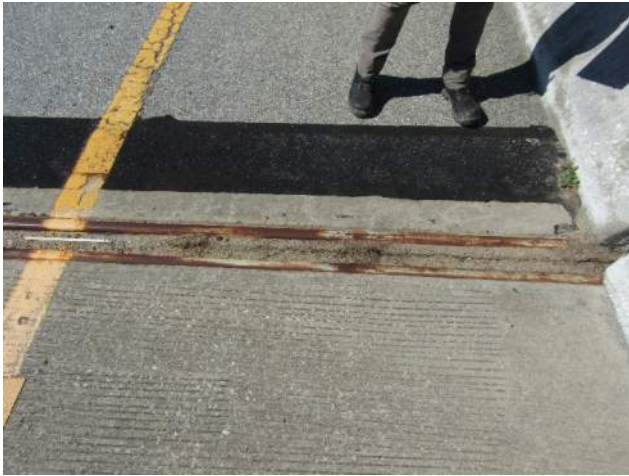
There is significant debris piling up in the shoulders of the joints at both ends of the bridge. As debris continues to fill in the joint there is risk of the expansion material splitting resulting in leakage onto the end bent and bearings. See photo #1. The 4-inch-thick concrete layer previously added to the top of far MSE wall is still intact and functioning as intended. See photo #2. Severe erosion is occurring along the base of the MSE wall adjacent to I-385 at the trailing end of the bridge. Multiple block panels have broken off from the wall at this location and are missing. As a result, there is a significant gap forming between the MSE wall block panels with sediment backfill flowing out the gaps. See photo #3. A large tree was previously growing on the top of the MSE wall at trailing end of the bridge, it has since grown back. See photo #4. Both delineators at the leading end of the bridge have lost their retroreflective quality.

#1 185-171: Debris buildup full length of joint

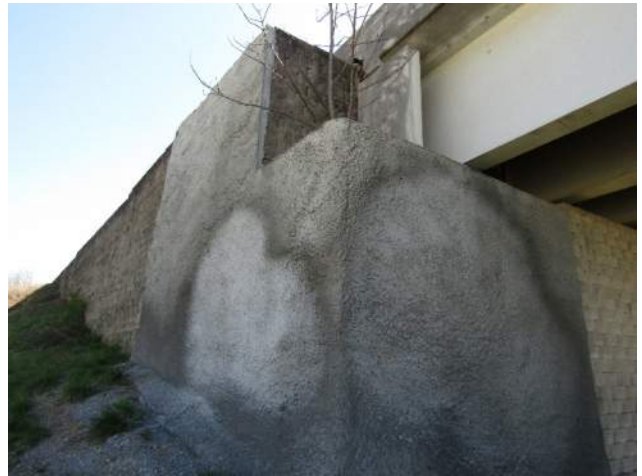
#2 185-171: 4 inch thick layer added to MSE wall

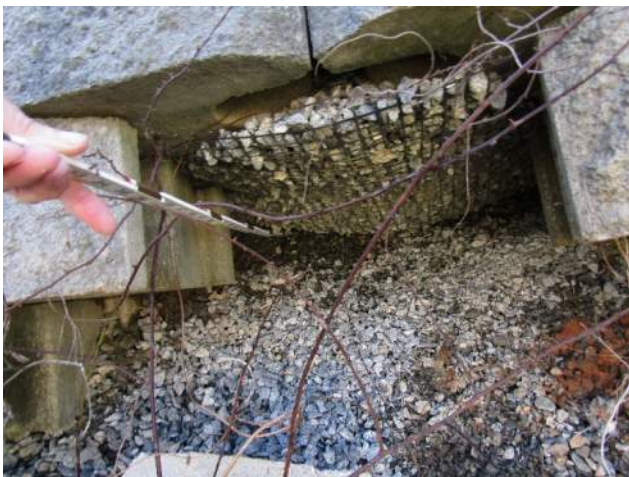
#3 185-171: Missing MSE wall blocks

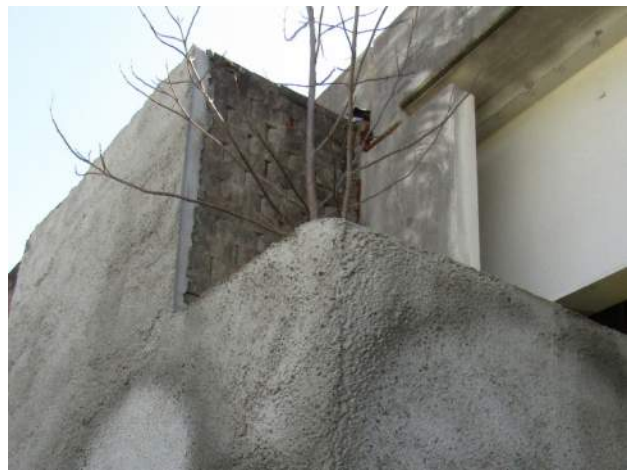
#4 185-171: Tree growing on top of MSE wall

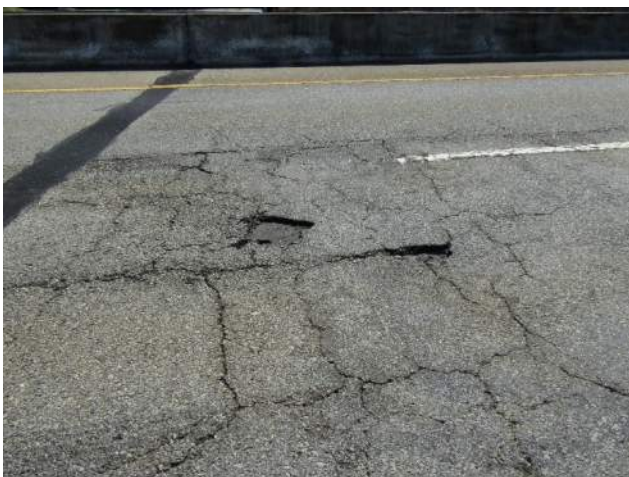
Severe block cracking and potholes were noted along the asphalt just before the approach slabs at each end of the bridge. See photo #5. There are multiple spalls in the median rail at both ends of the bridge. See photos #6-#7. Heavy vegetation growth has been cut and is dead along the MSE wall. See photo #8. At the northeast corner of the bridge, there is a large hole underneath the drainage flume and the drainage flume is partially clogged with debris. See photo #9. Cracks are beginning to form at the bridge joints with vegetation growing in the shoulders. See photo #10. There are multiple guardrail post blocks that are damaged or completely missing at the southwest approach. See photo #11. The delineator at the southwest corner has lost its retroreflective quality.

#5 185-001: Severe block cracking and potholes

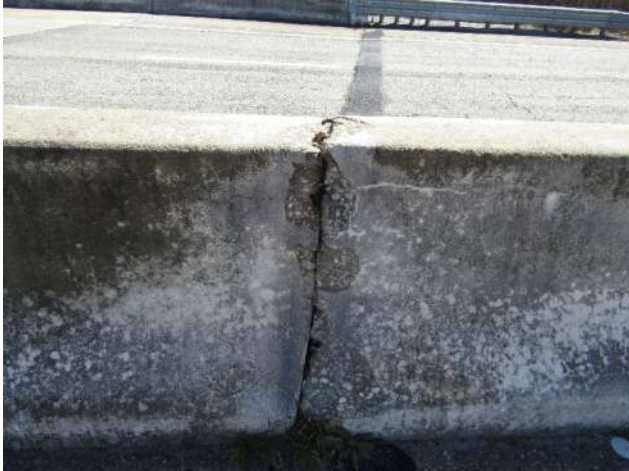
#7 185-001: Spalls in median rail

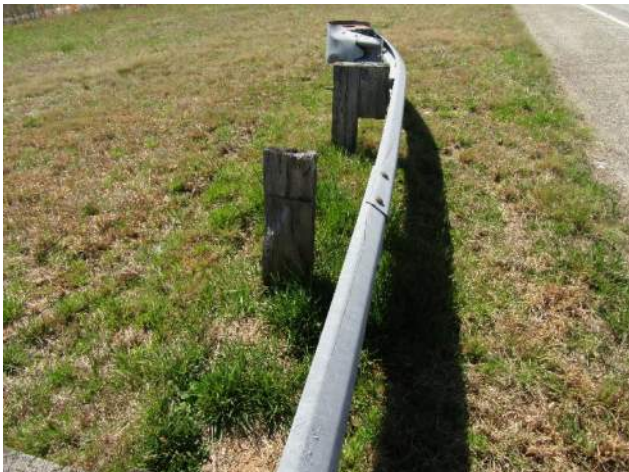
#11 185-001: Missing guardrail post blocks

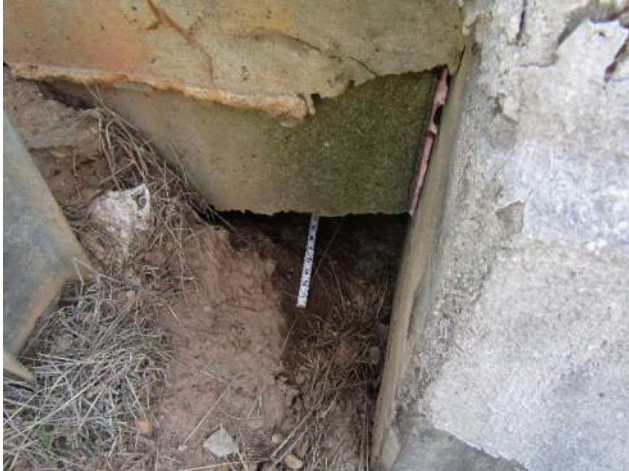
The NB bridge approach end has several defects: clogged drainage flume, loose guardrail anchorage bolt, and undermining of the approach slab. See photos #12-#14. The expansion joints at both ends of the bridge have significant debris buildup throughout the entire length of the joint and tears are beginning to develop. See photo #15. The NB bridge trailing slope protection was previously repaired for the entire length and is still in good condition. Spall repair on the north side of the last interior bent column on the NB bridge is beginning to delaminate. The NB bridge trailing end has 4 inch shoulder settlement and cracking adjacent to the catch basin. See photos #16-#17. At the top of the northwest slope protection corner, there is large cracking with settlement occurring. See photo #18.

#13 185-002: Erosion underneath approach slab

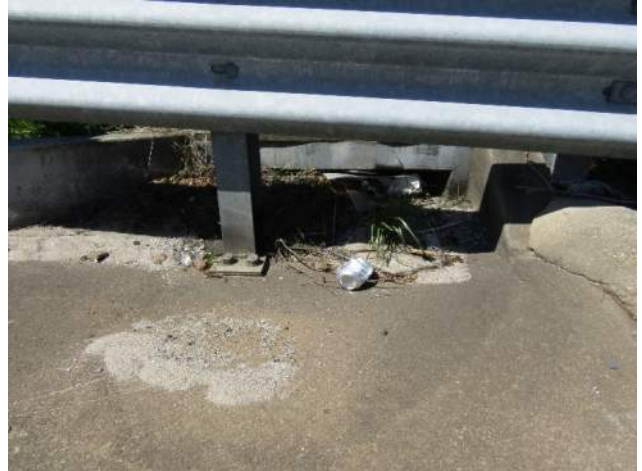
#14 185-002: Clogged drainage flume

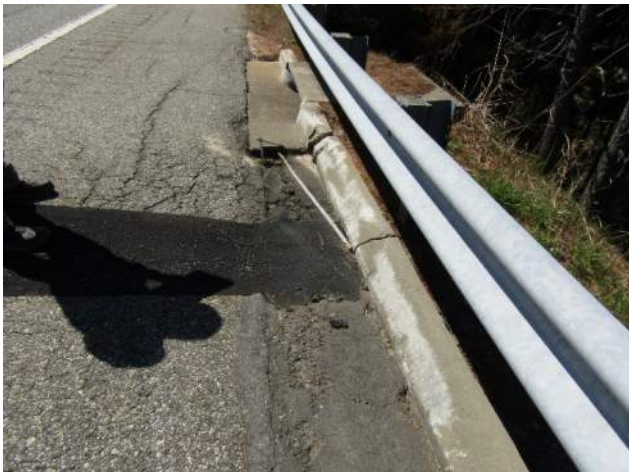
#17 185-002: Shoulder settlement and cracking

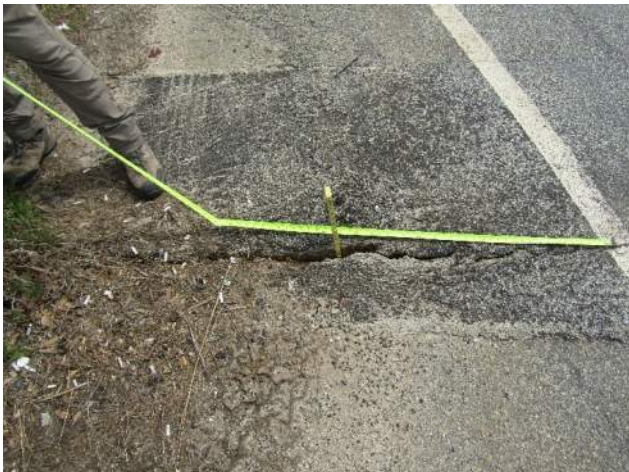
#26 S-144-001: Full depth crack at end of approach slab

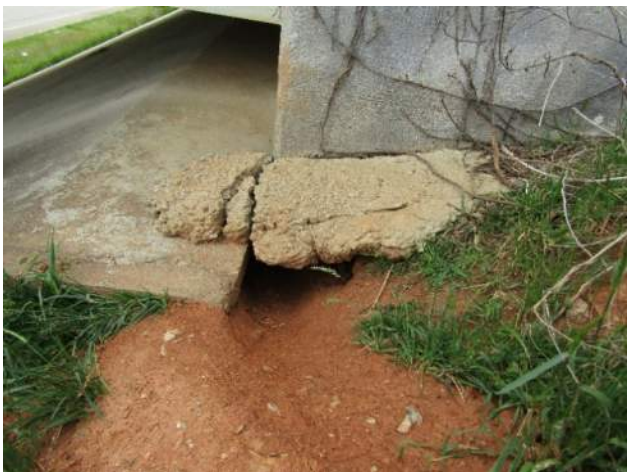
#28 S-144-001: Cracking in slope protection

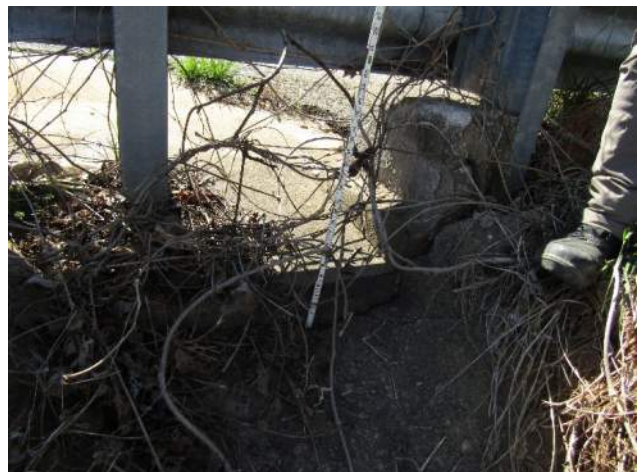
#29 S-144-001: Animal hole with undermining of slope

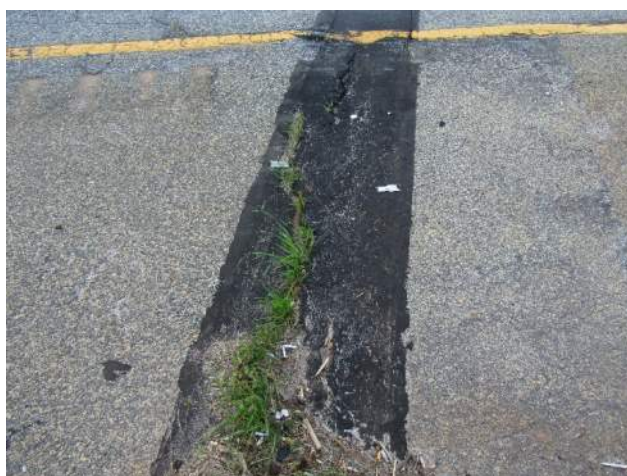
#41 185-104: Longitudinal cracks with potholes

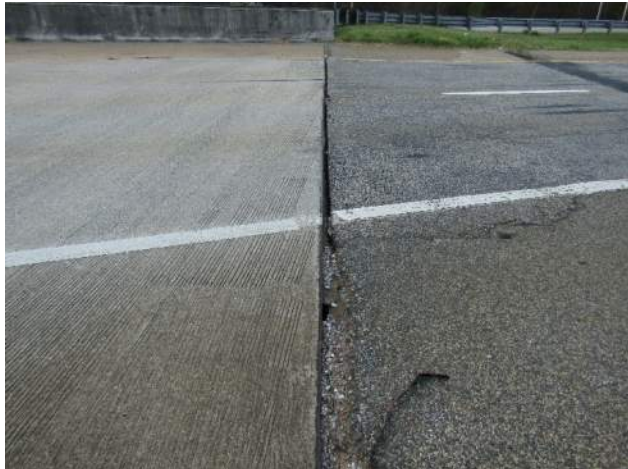
#42 185-304: Approach slab joint deterioration

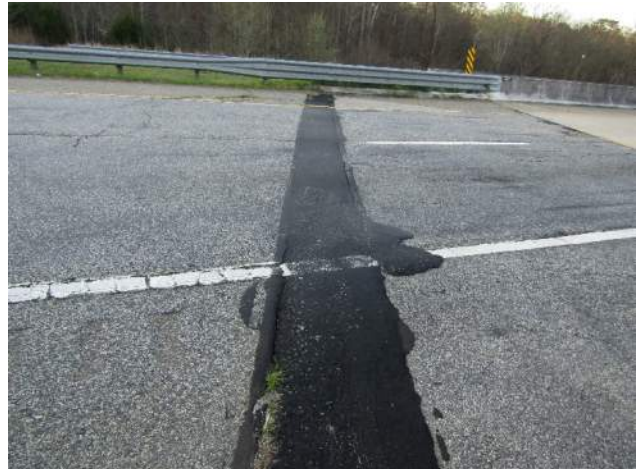
#43 185-104: Joint deterioration adjacent to deck

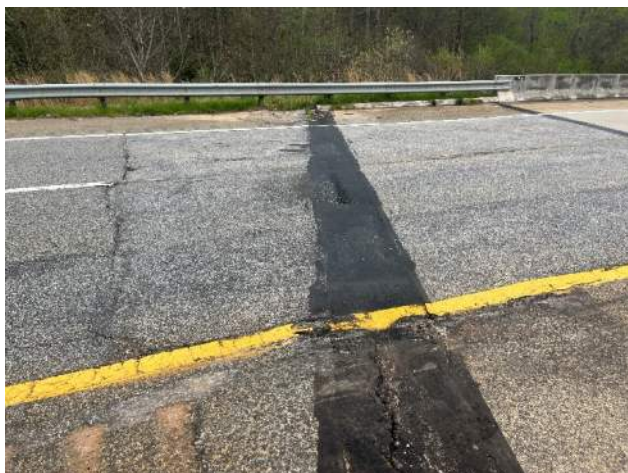
#46 185-304: Approach roadway block cracking

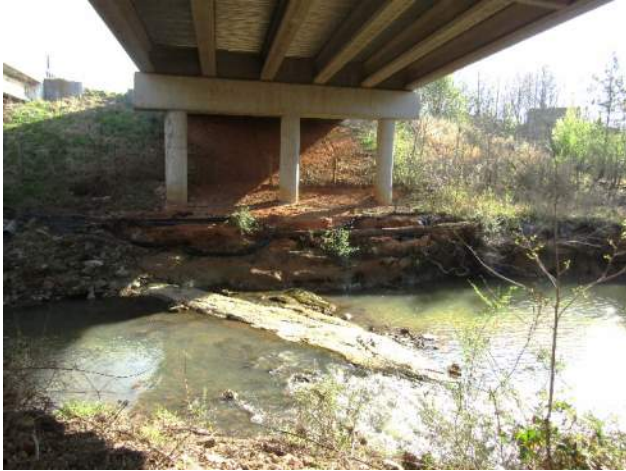
#60 185-305: Severe streambank erosion

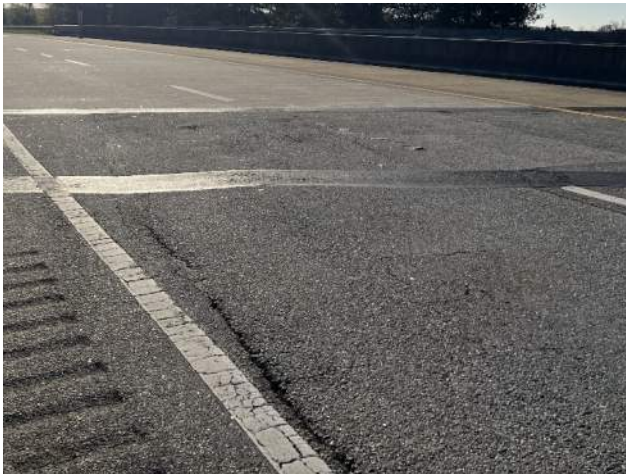
#63 185-106: Longitudinal cracking in approach roadway

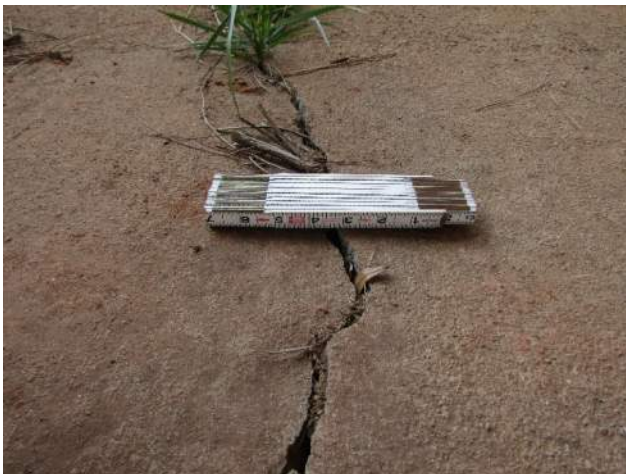
#65 185-306: Cracking and settlement in concrete slope protection

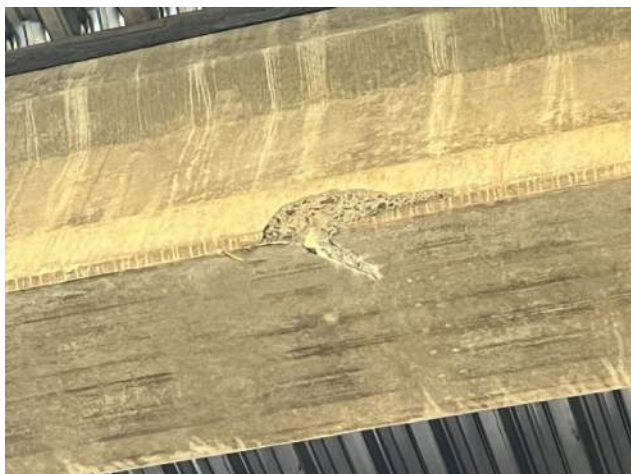
#67 185-106: Minor spall in bottom flange

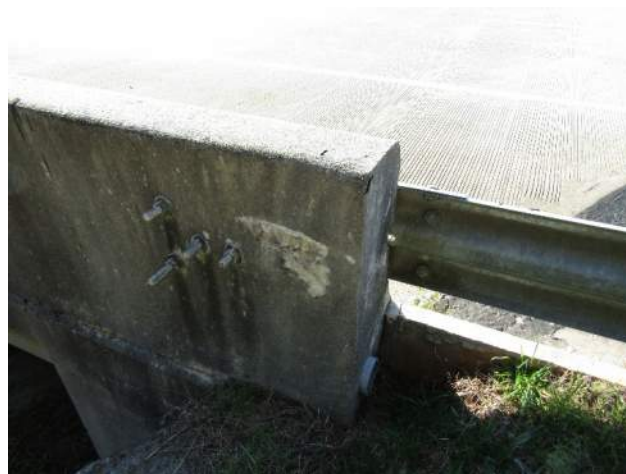
#68 185-106: Rail crack with efflorescence

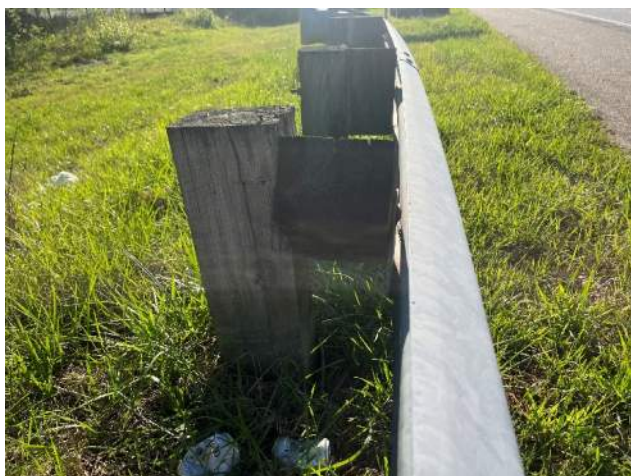
#69 185-107: Multiple dislodged guardrail post blocks

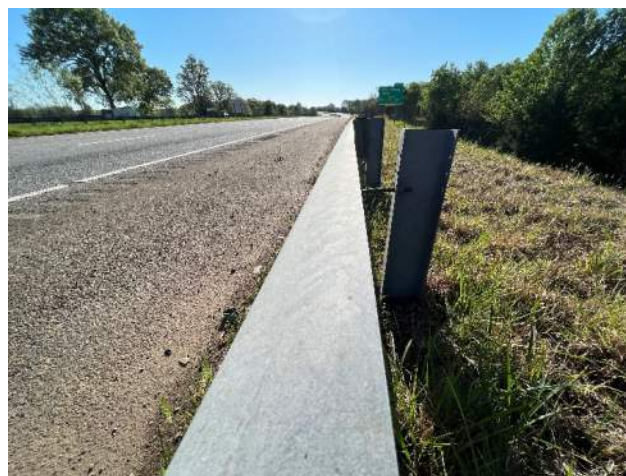
#70 185-307: Missing guardrail post block

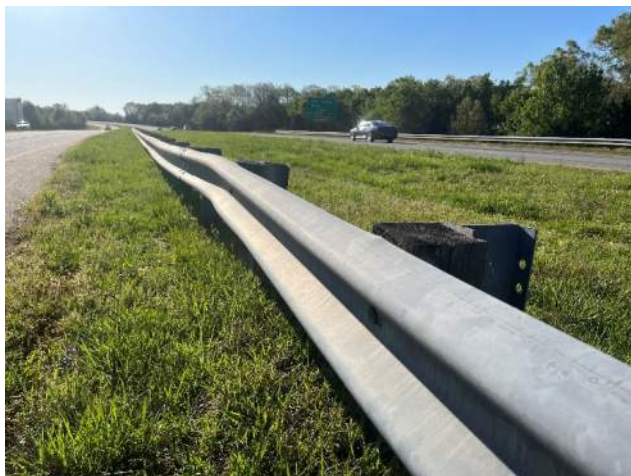
#71 185-107: Guardrail impact damage

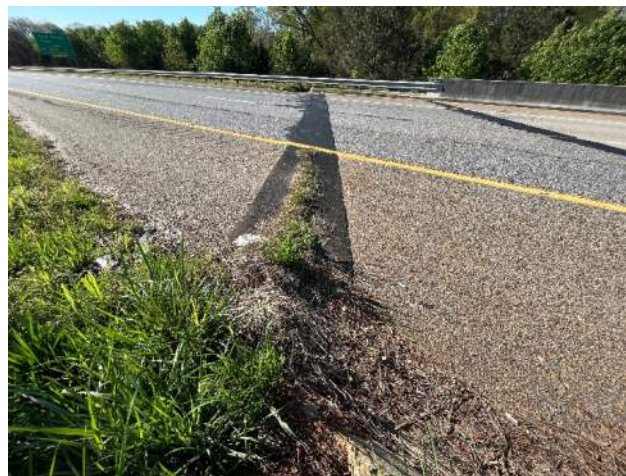
#72 185-307: Cracking and vegetation growth in approach slab joint

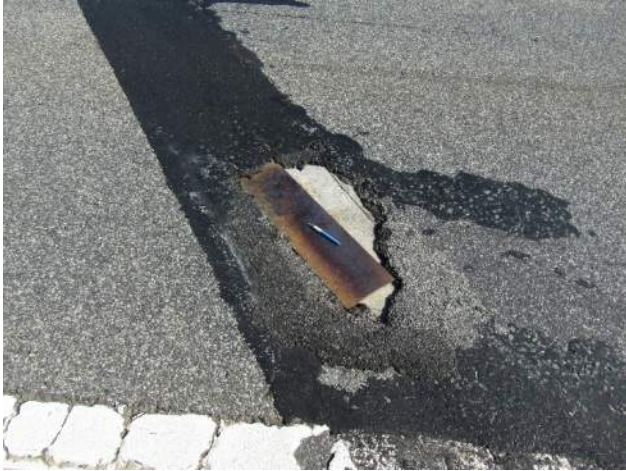
#73 185-307: Approach slab joint pothole

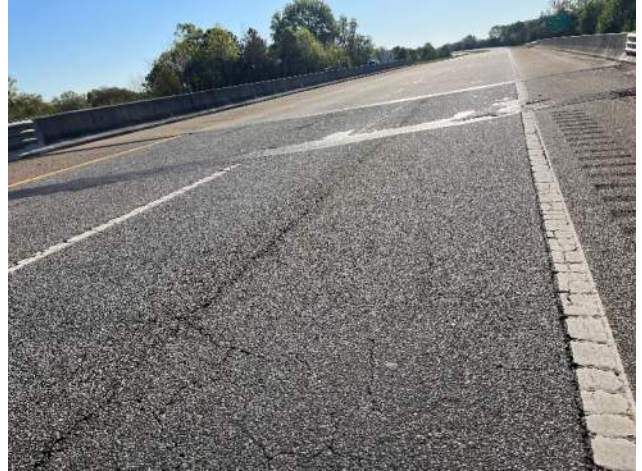
#74 185-307: Longitudinal cracking in approach roadway

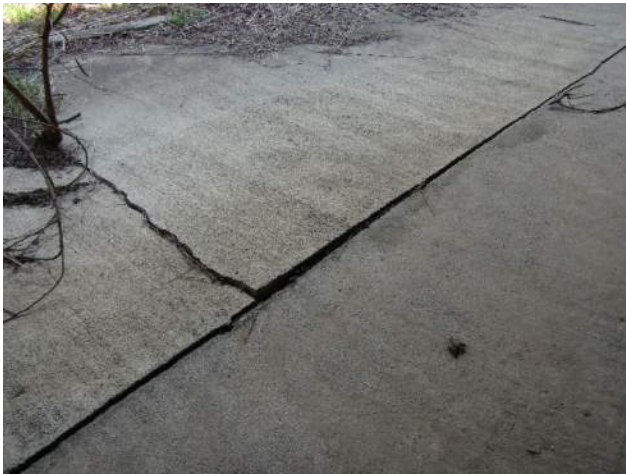
#75 185-107: Cracking and settlement in slope protection

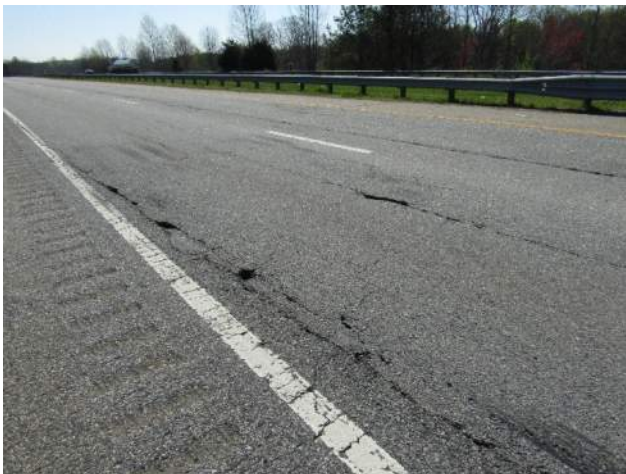
#77 185-108: Block cracking with potholes

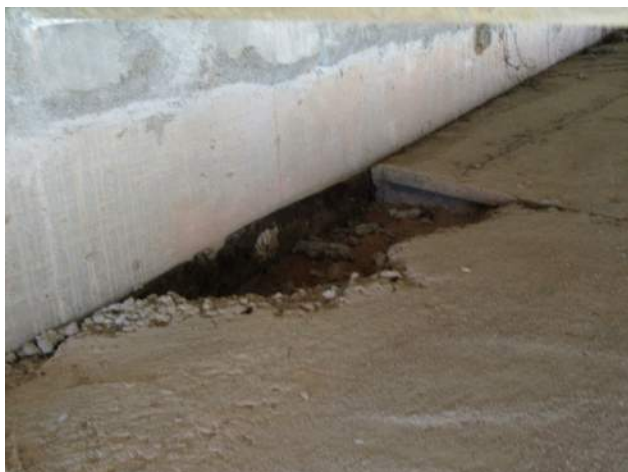
#79 185-308: Top berm concrete spall

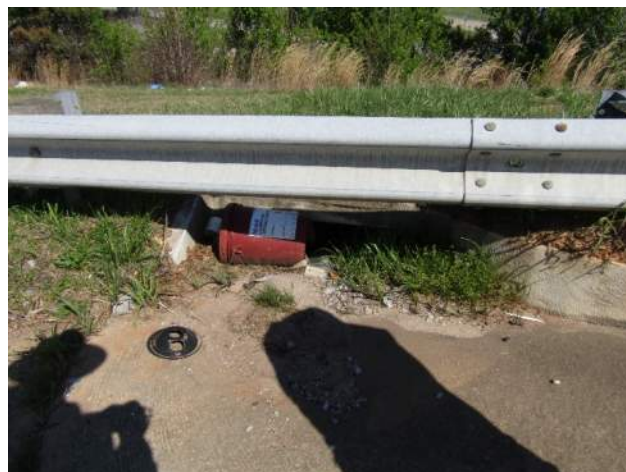
#80 185-109: Clogged drainage flume

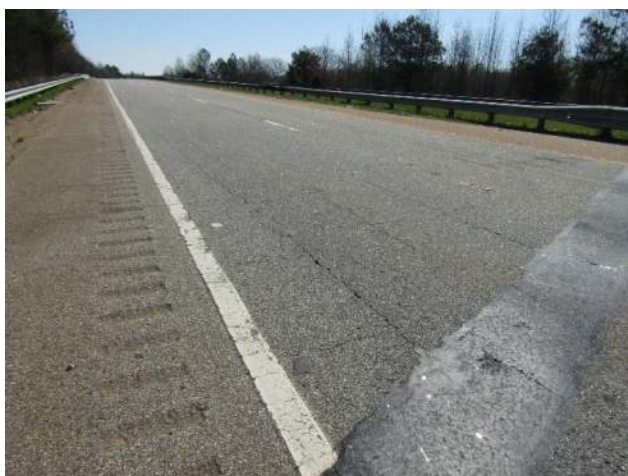
#81 185-109: Severe block cracking

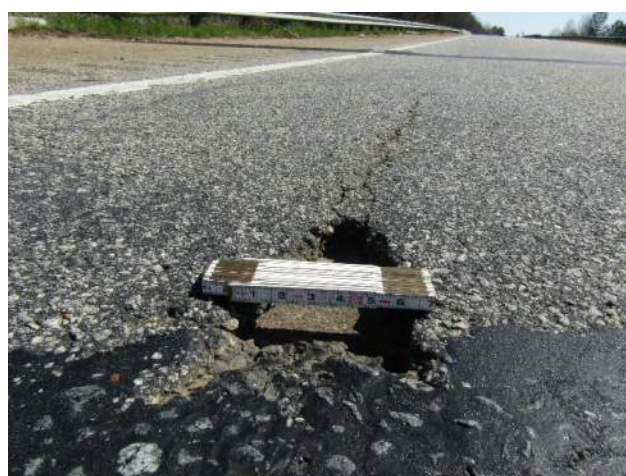
#82 185-109: Severe block cracking with pothole

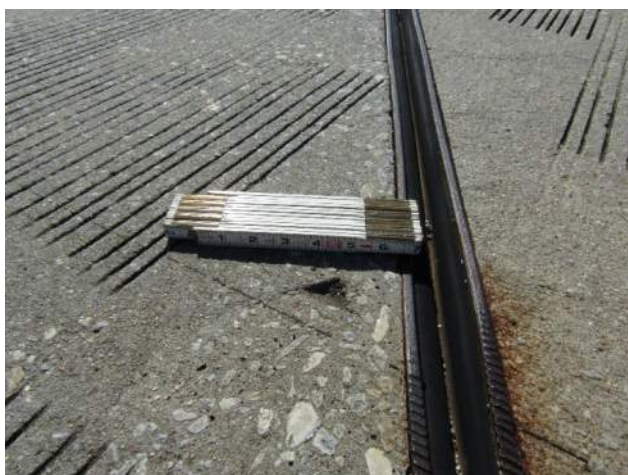
#83 185-309: Seal adhesion loss

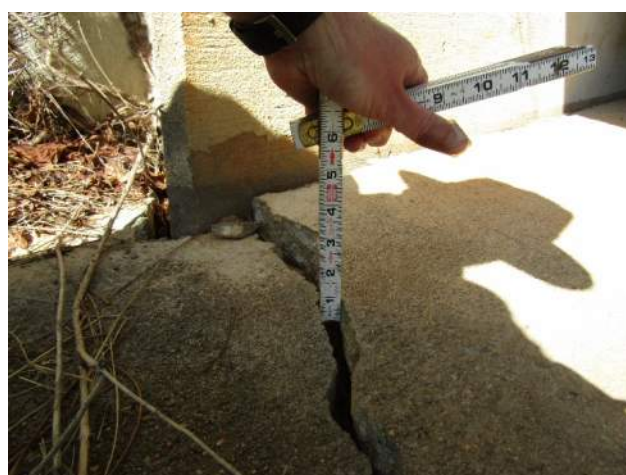
#84 185-309: Cracking and settlement of concrete berm

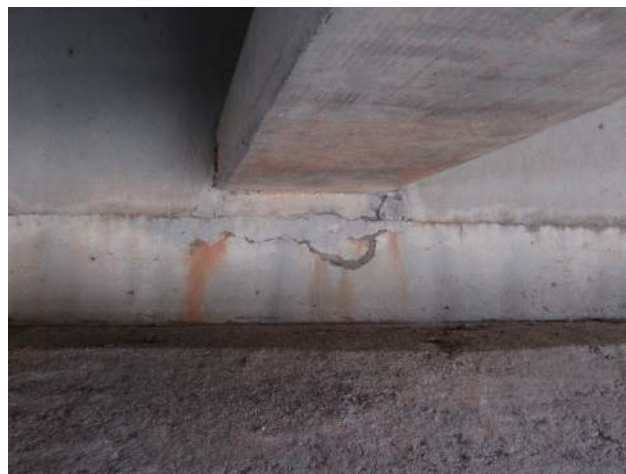
#86 25-001: Cracking beneath girders and abutments

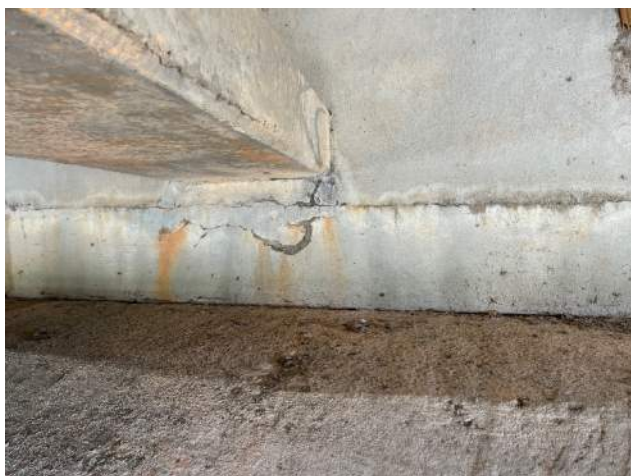
#87 25-001: Cracking beneath girders and end bents

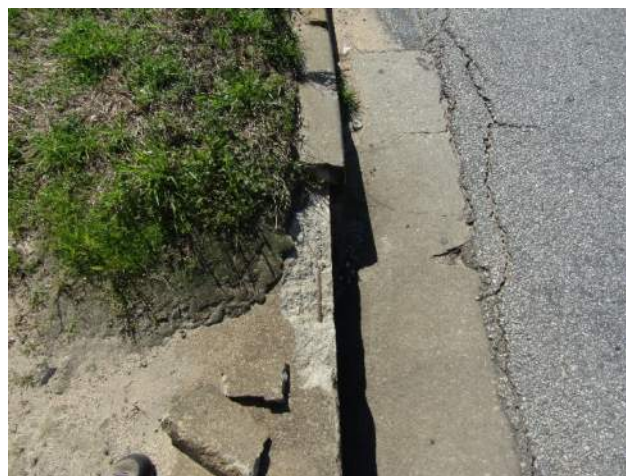
#88 25-001: Broken curb above catch basin

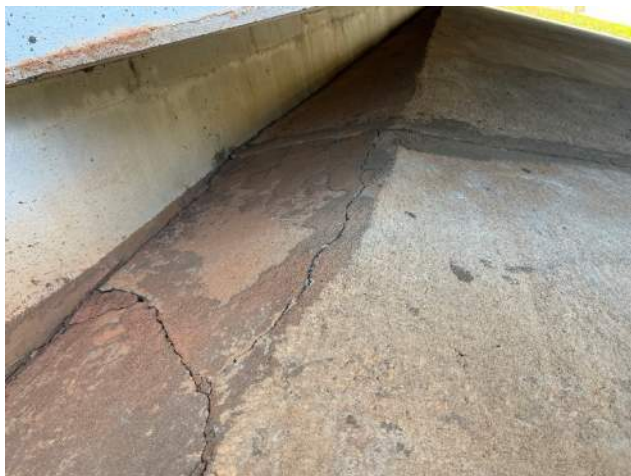
#89 25-001: Cracking and minor settlement along concrete berm

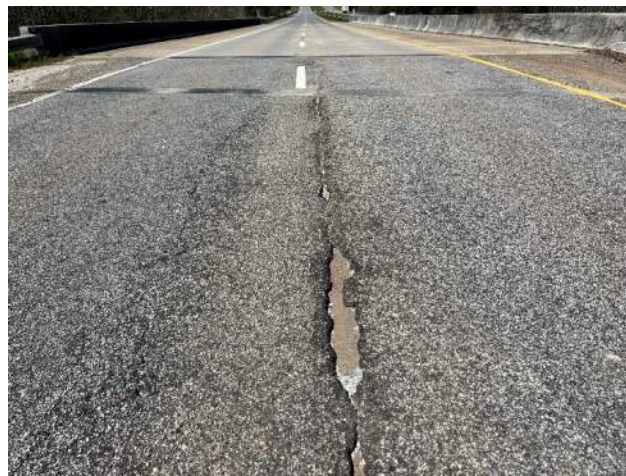
#90 185-310: Longitudinal crack with pothole

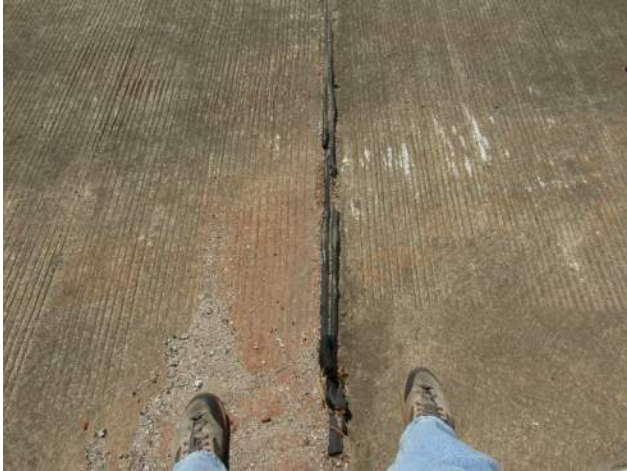
#91 185-110: Deteriorated compression joint seal

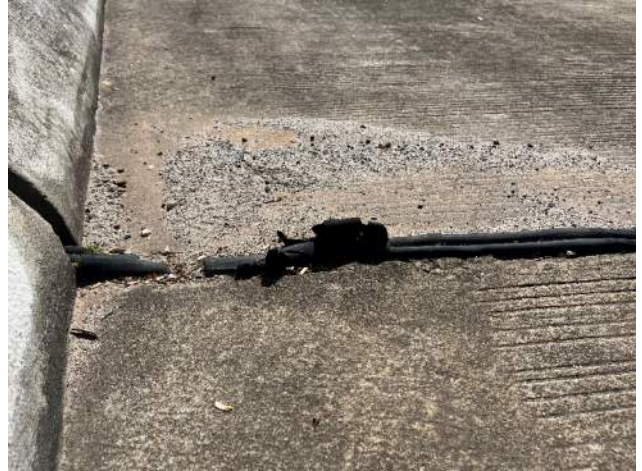
#92 185-110: Broken compression joint seal

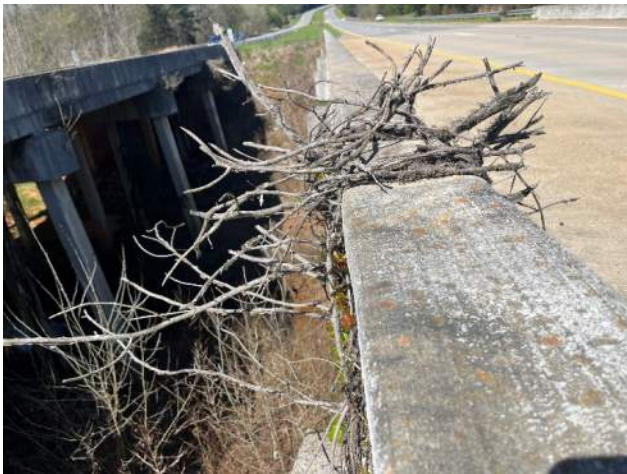
#93 185-110: Dead vegetation on barrier rail

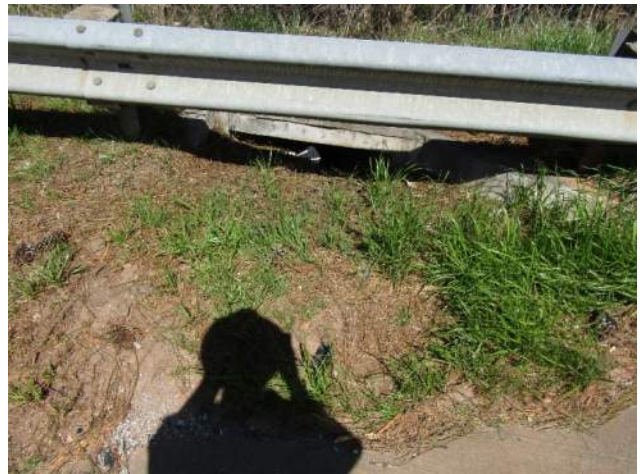
#94 185-110: Partially clogged drainage flume

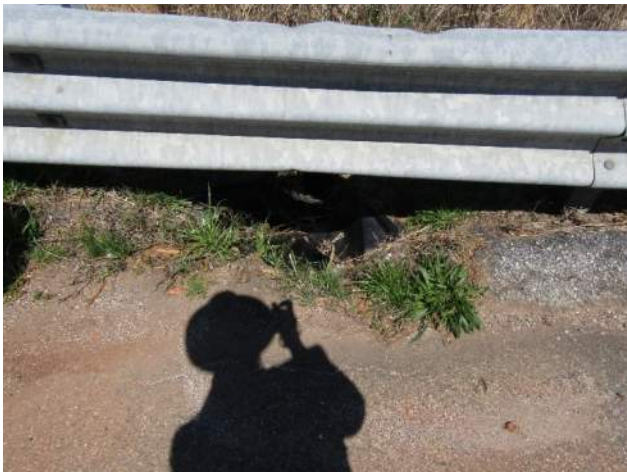
#95 185-110: Partially clogged drainage flume

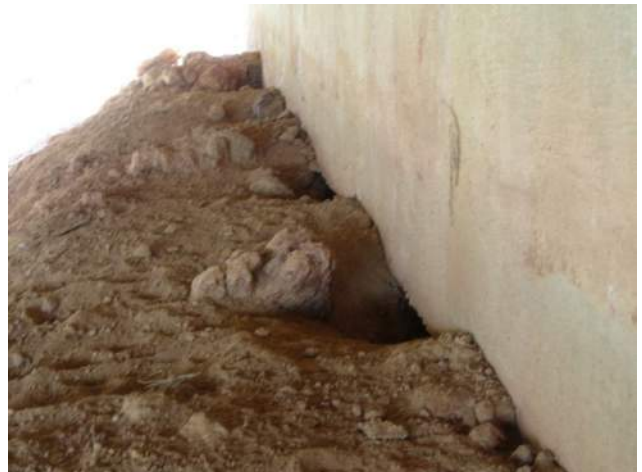
#96 185-310: Undermining of end bent

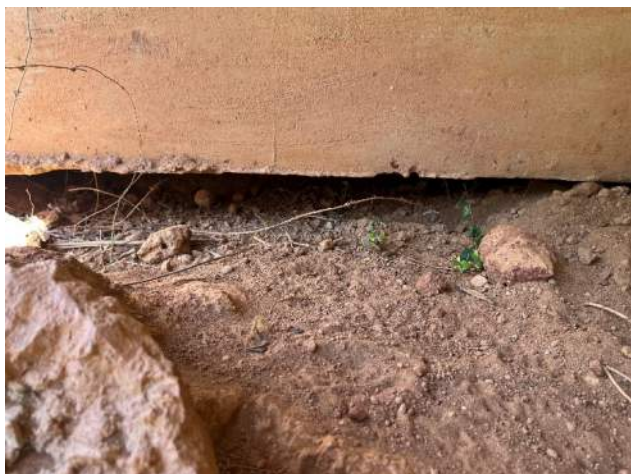
#97 185-310: Undermining of end bent

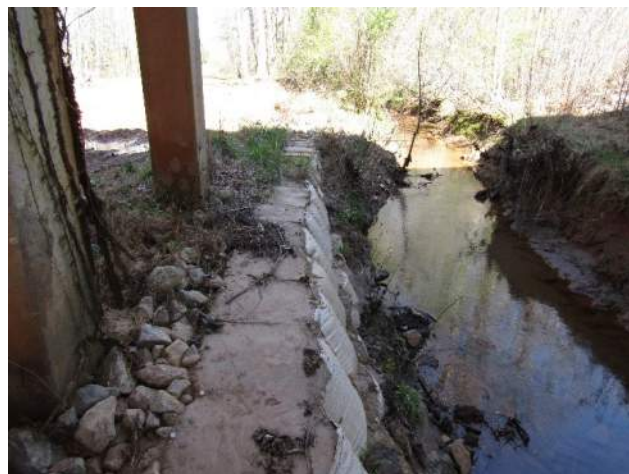
#98 185-110: Streambank erosion control device

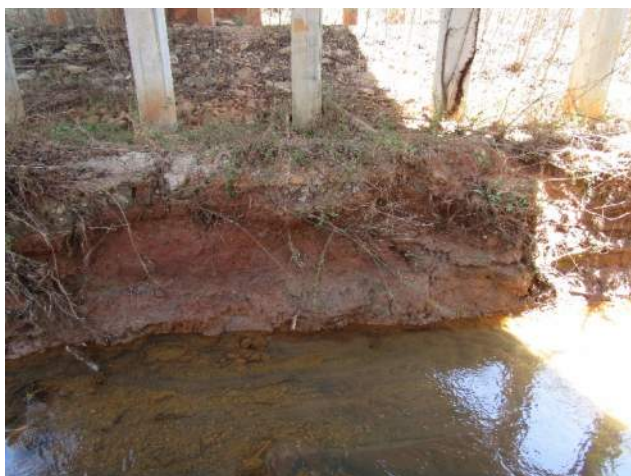
#99 185-110: Streambank erosion

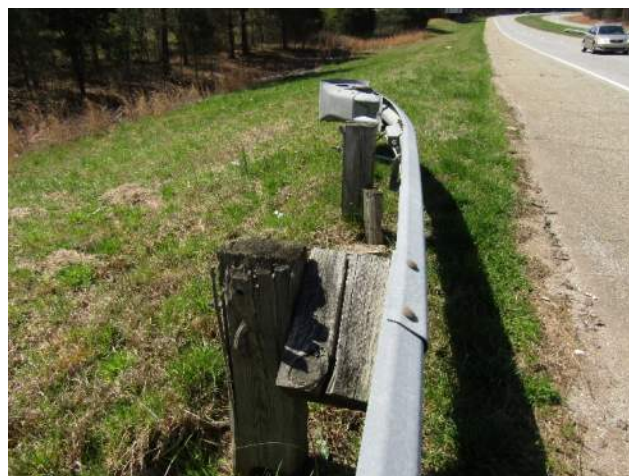
#100 185-311: Damaged block by terminal

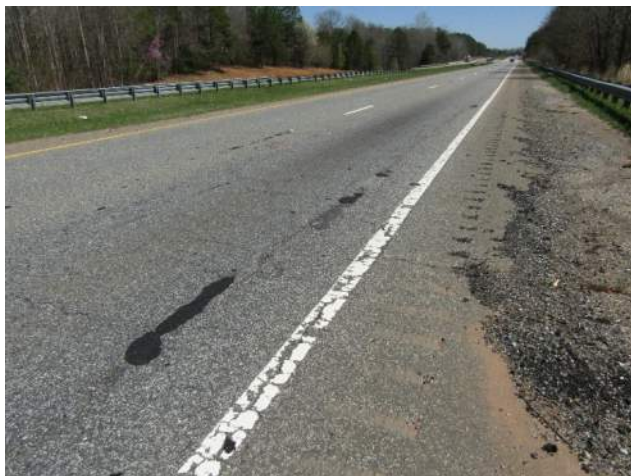
#101 185-311: Block cracking with potholes

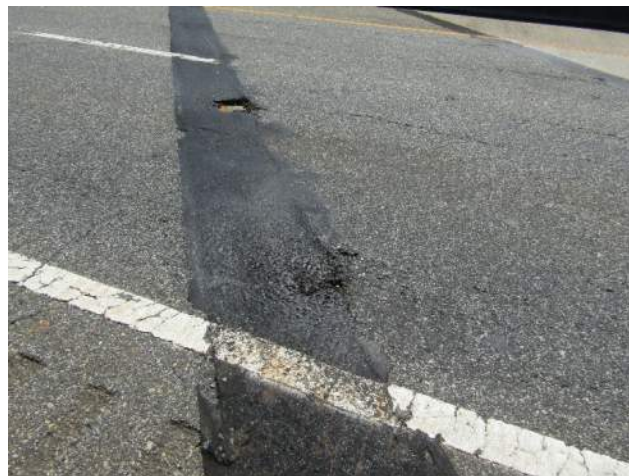
#102 185-111: Block cracking with potholes

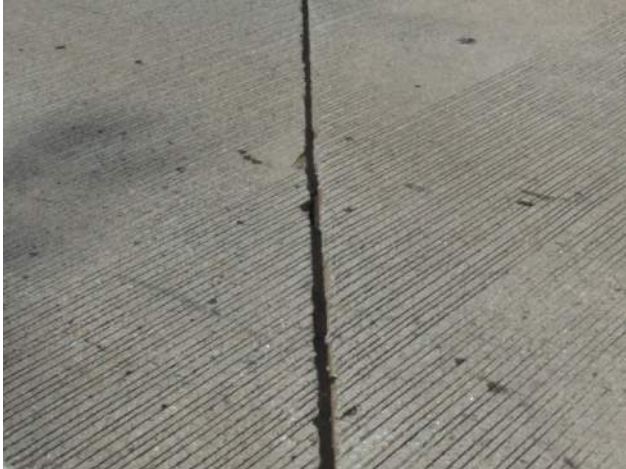
#103 185-311: Spall adjacent to compression joint

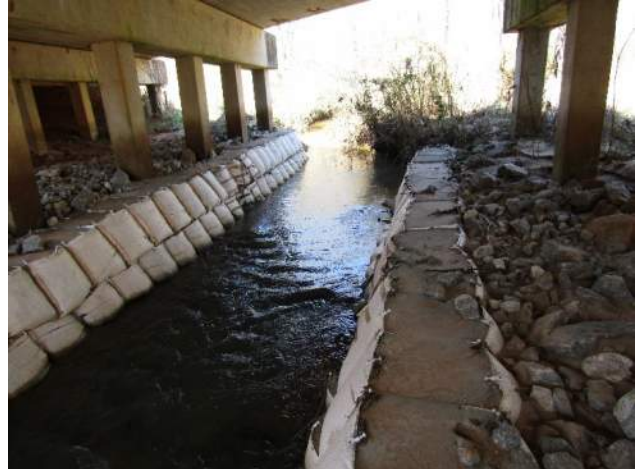
#104 185-111: Erosion control device

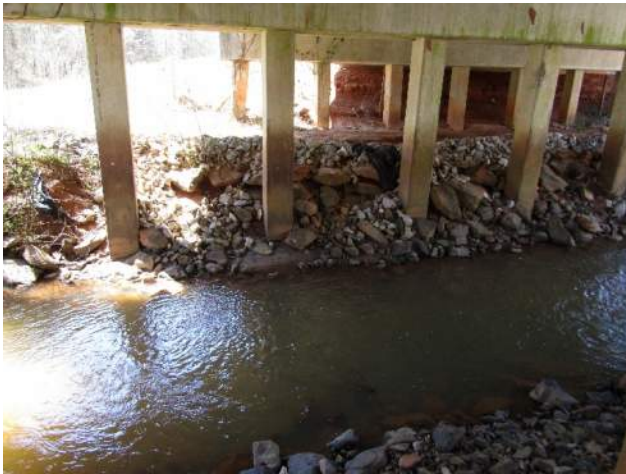
#105 185-311: Streambank erosion adjacent to bent

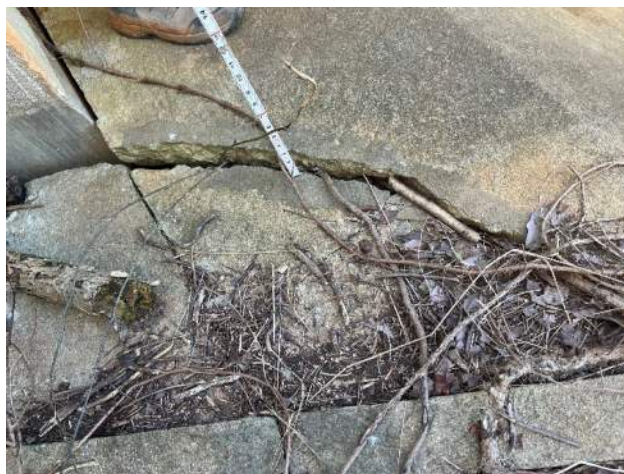
#109 185-1271: Block cracking and pothole in joint

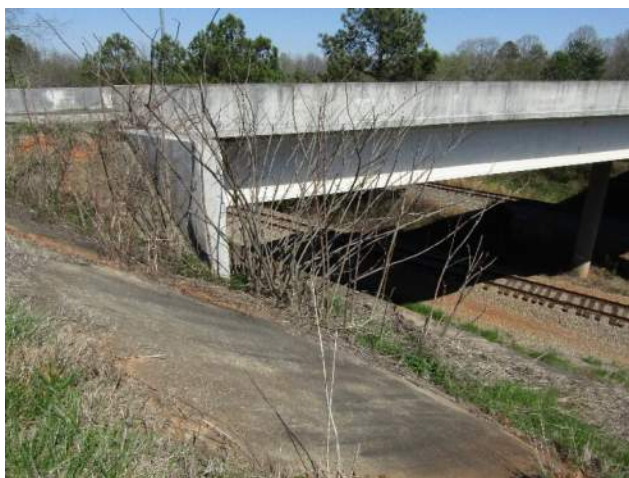
#110 185-1271: Concrete berm crack and settlement

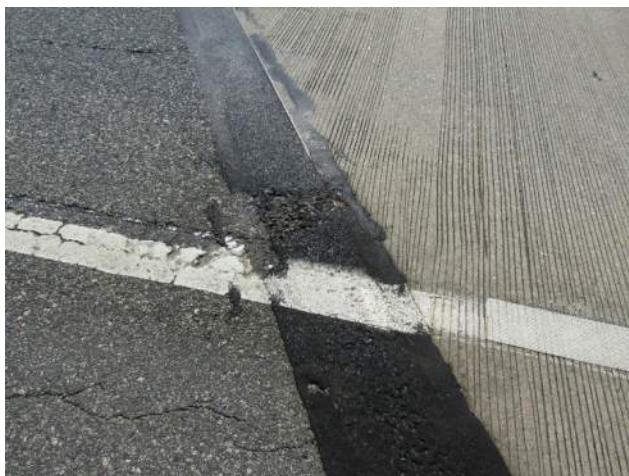
#112 185-313: Severe block cracking with potholes

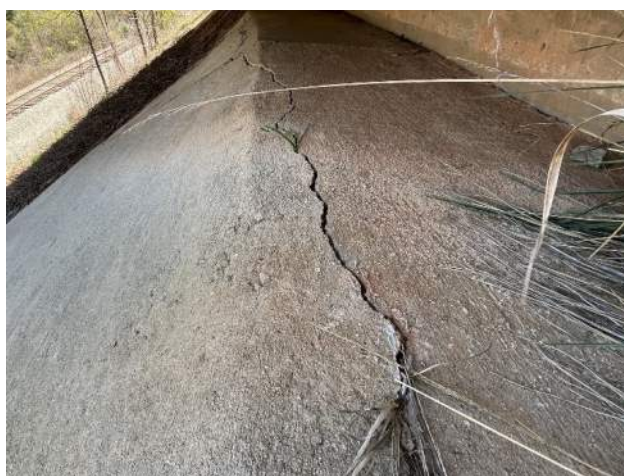
#113 185-113: Approach slab joint deterioration

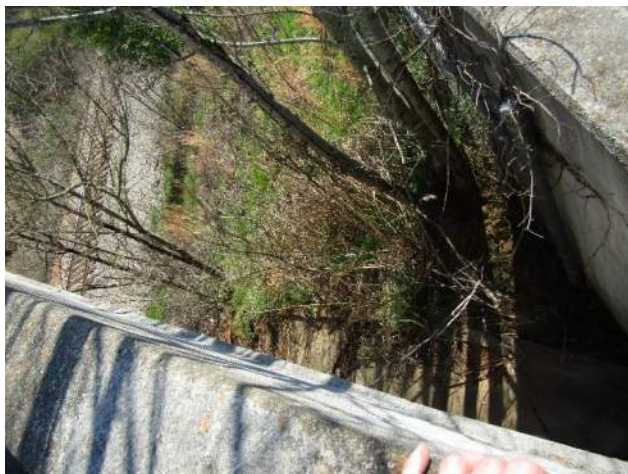
#114 185-1272: Concrete berm cracking
