# ANNUAL SURVEY REPORT ON CONDITION OF SOUTHERN CONNECTOR TOLL ROAD

## Interstate 185 - Toll

Greenville County, South Carolina

May 3, 2024

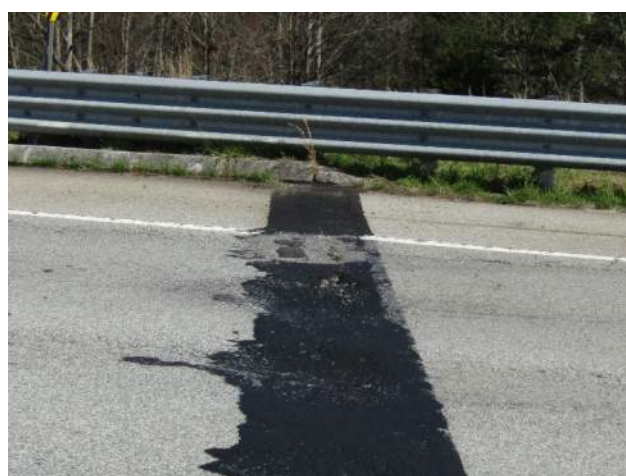
#117 185-314: Severe block cracking with potholes

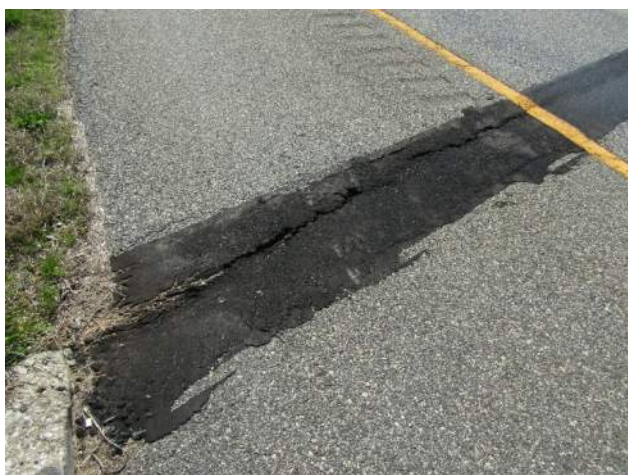
#118 185-114: Approach slab joint deterioration

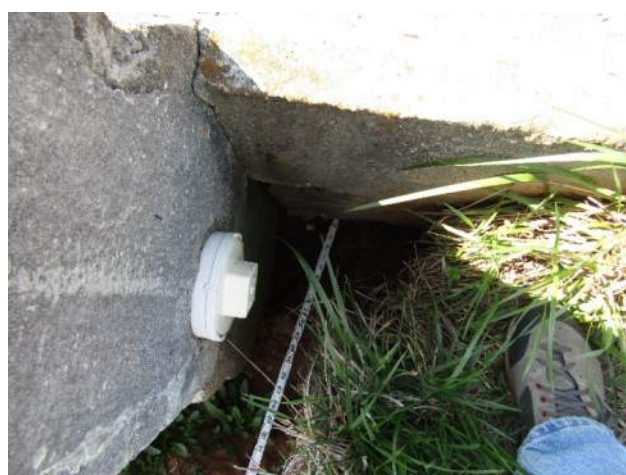
#119 185-314: Approach slab joint deterioration

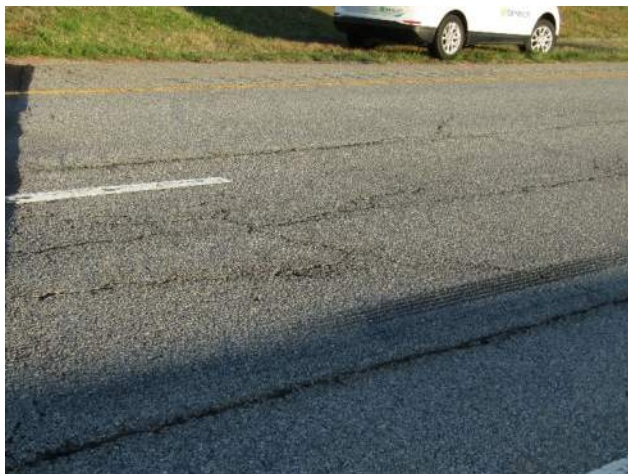
#120 185-114: Approach slab undermining

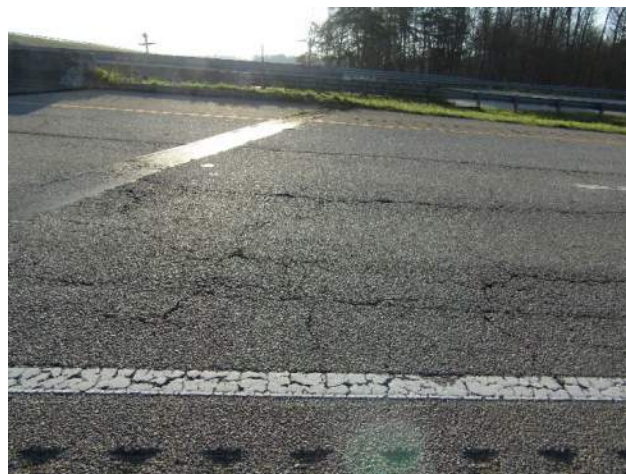
#121 185-115: Severe block cracking

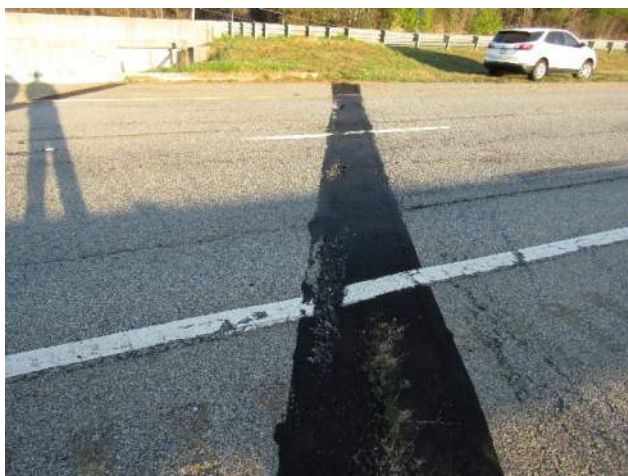
#122 185-315: Severe block cracking

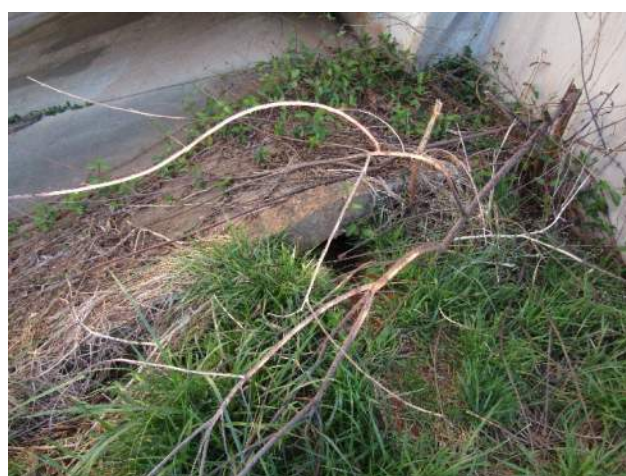
#123 185-115: Approach slab joint deterioration

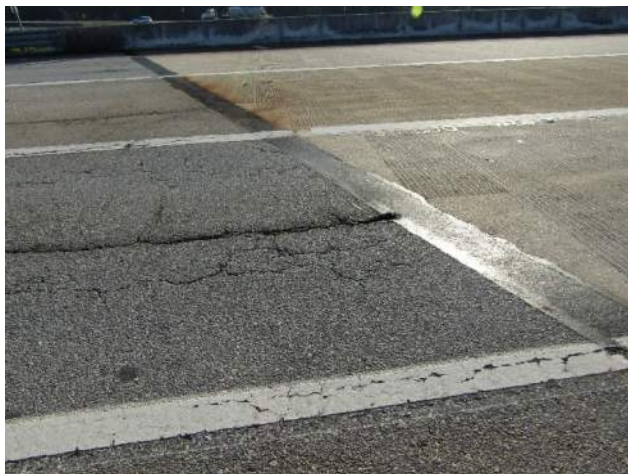
#126 185-316: Cracking and large bump in roadway

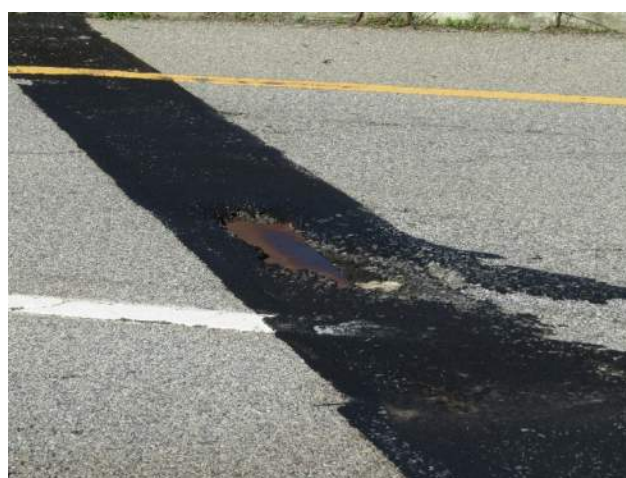
#129 185-117: Severe block cracking with potholes

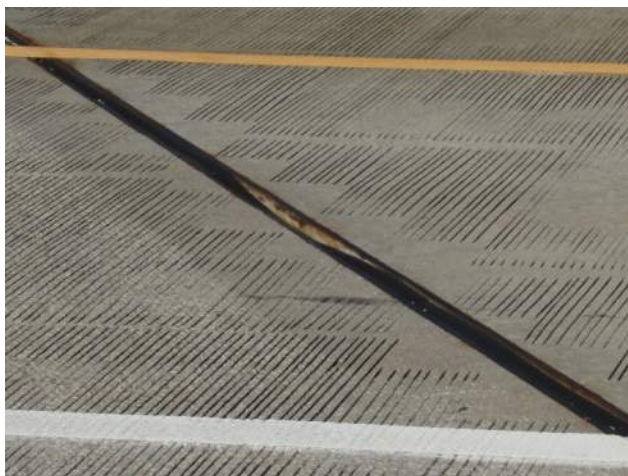
#130 185-117: Deteriorated joint with exposed plate

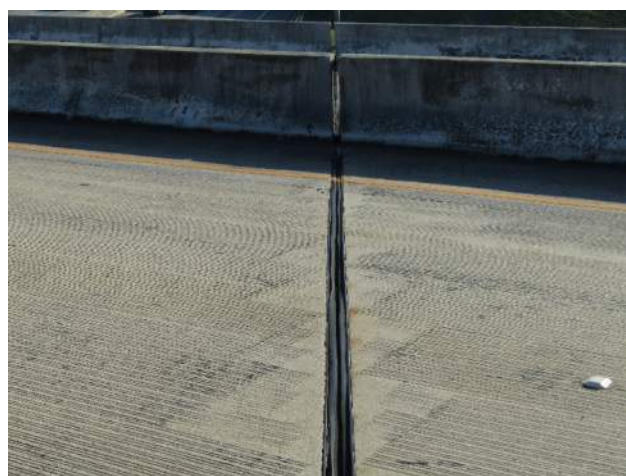
#131 185-117: Compression joint adhesion loss

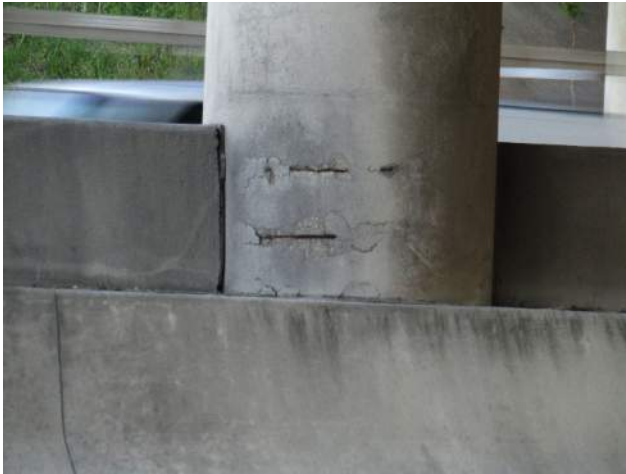
#134 185-317: Spall in column

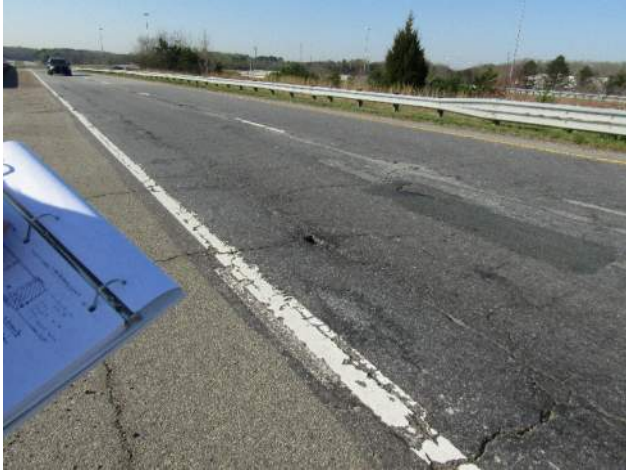
#138 185-118: Severe block cracking

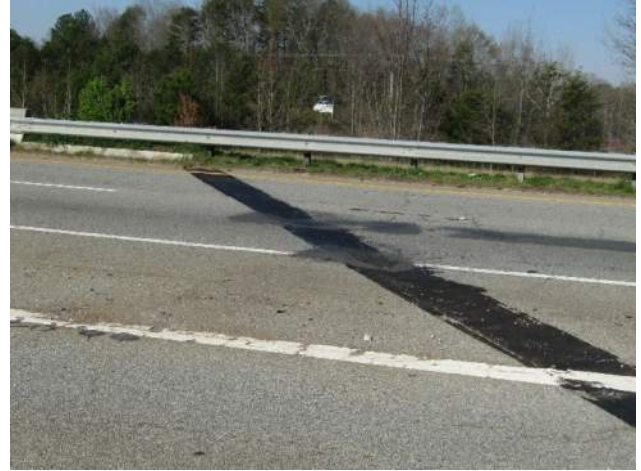
#139 185-118: Severe block cracking
